#### BMW 5: 1GWX465

| Vinnnumber: | <b>WBA5J11000D065816</b> | Versionname: | <b>5 TOURING 518dA 136PK Aut.</b> |

#### Limited Technical Inspection

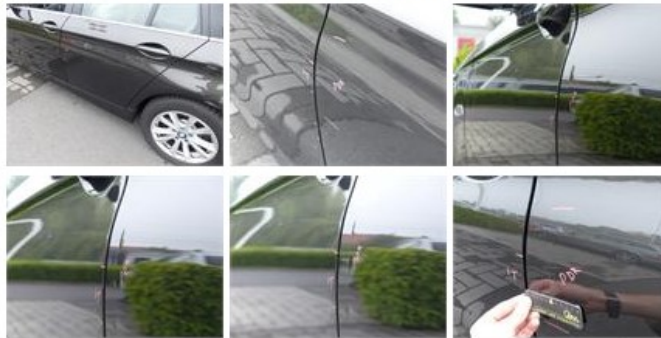
| Door R L, Bump(s), PDR - Knock out without painting | 63,00 |

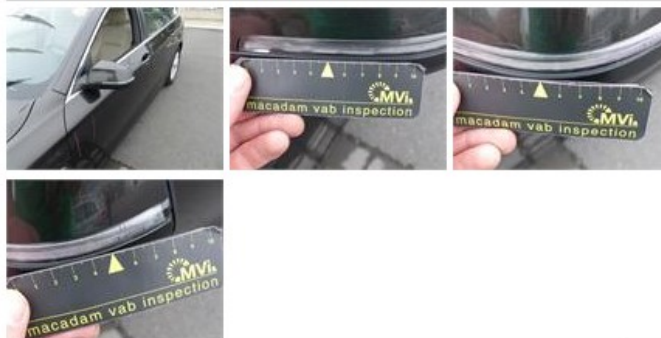
| Mirror side blinker L, Waterinfiltration, E - Replace | 31,20 |

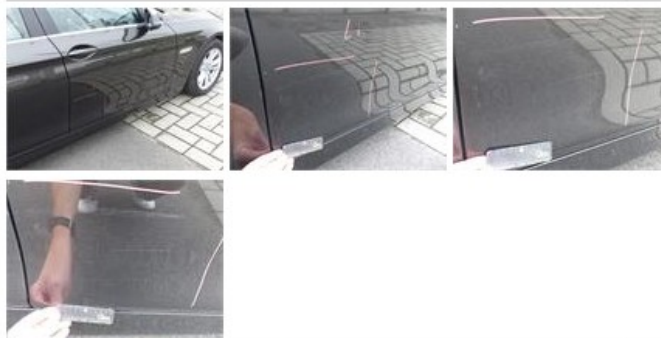
| Door F R, Scratch(es), LI - Repair and paint (complete) | 430,02 |

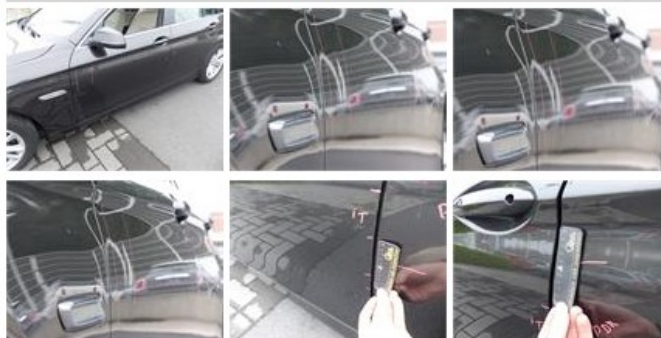
| Door F L, Bump(s) and scratch(es), It - Spot repair | 115,56 |

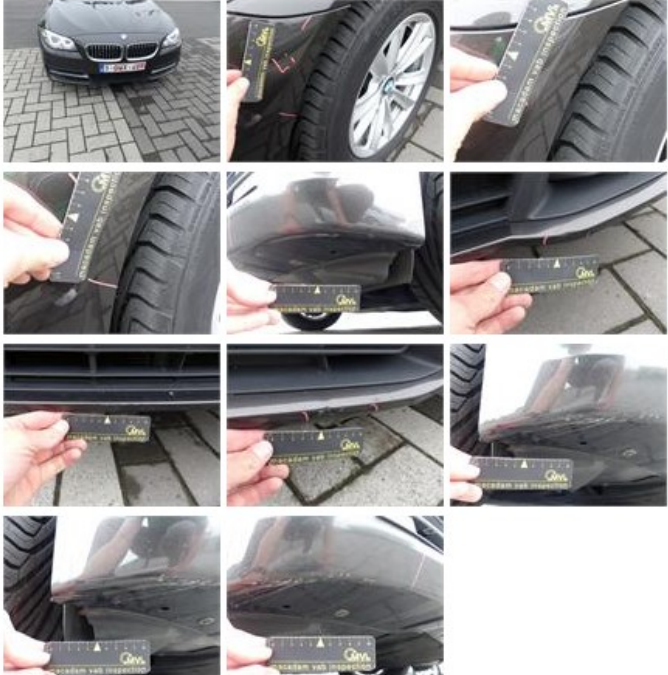
| Front bumper, Scratch(es), LI - Repair and paint (complete) | 278,16 |
