# FORD Grand C-Max: 1LXB664

| Vinnnumber: | <b>WF0HXXWPBHET28957</b> | Versionname: | <b>GR.C-MAX Trend St/St</b> |

## Limited Technical Inspection

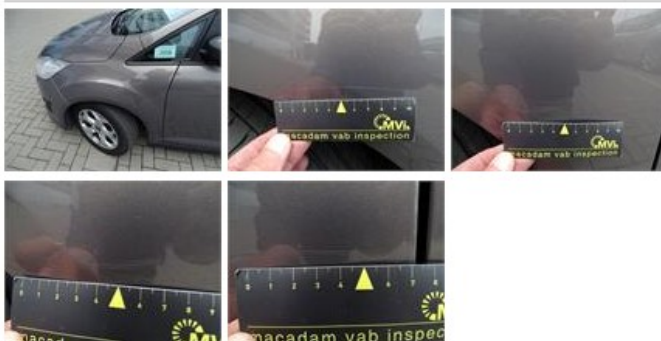
| Wing F L, Scratch(es), LI - Repair and paint (complete) | | | <b>220,18</b> |
