### BMW 3: 1GWI475

| Vinnnumber: | <b>WBA3K91050F934062</b> | Versionname: | <b>3 TOURING 316d 116PK</b> |

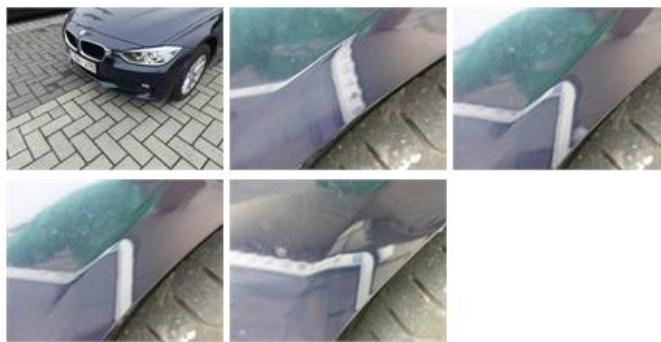
| Front bumper, Bad repair, Acceptable | 0,00 |

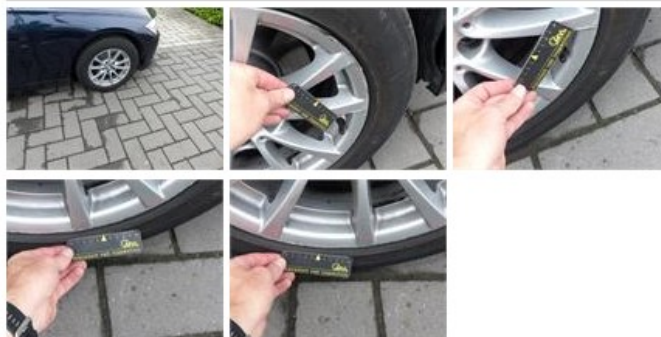
| Alloy rim F R, Damaged, LI - Repair and paint (complete) | 95,00 |

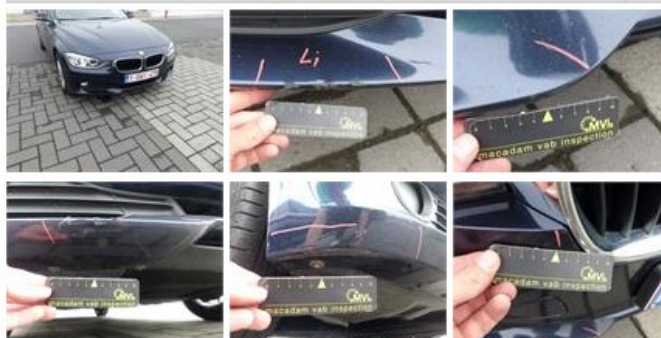
| Front bumper, Damaged, LI - Repair and paint (complete) | 235,80 |

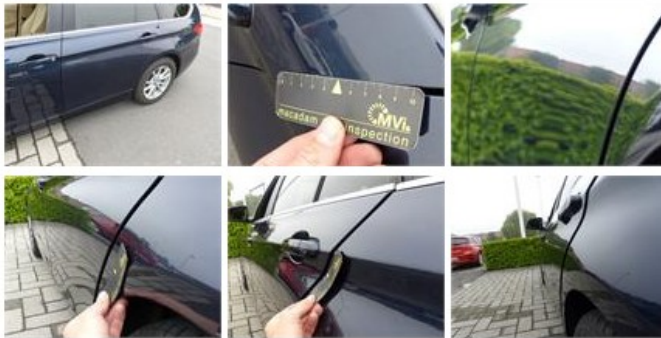
| Door R L, Bad repair, Acceptable | 0,00 |
