SKODA Superb: 1FTK004

Limited Technical Inspection

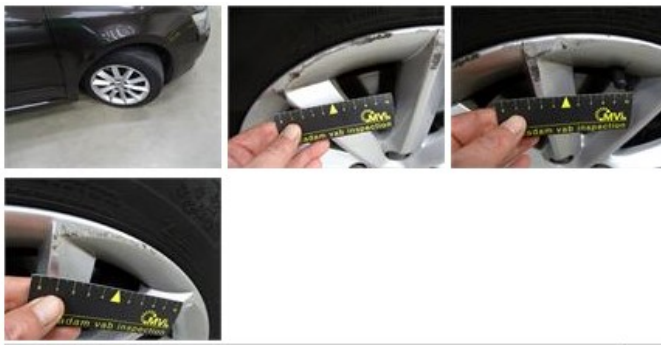
Alloy rim F R, Scratch(es), LI - Repair and paint (complete)	95,00
--	-------

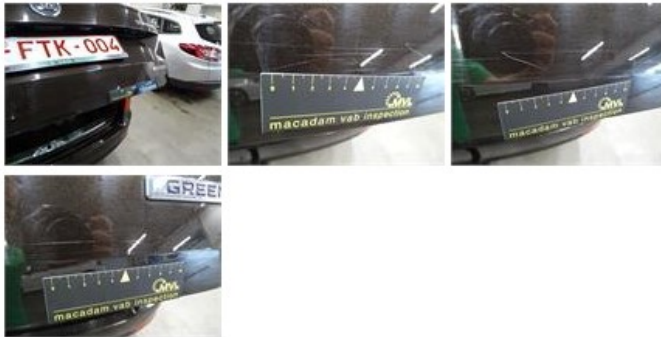
Tailgate, Scratch(es), LI - Repair and paint (complete) 362,02
