SKODA Octavia: 1GJJ294

Limited Technical Inspection

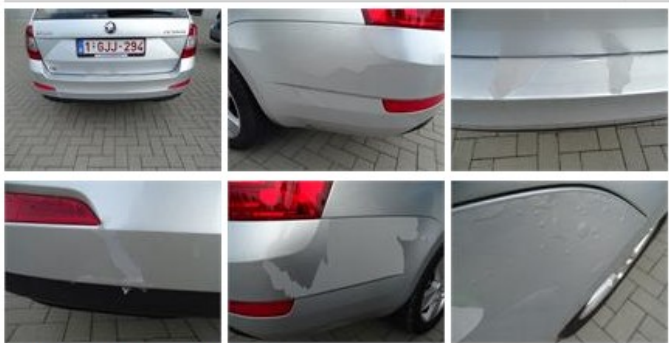
Bumper R, Bad repair, I - Repair 0,00

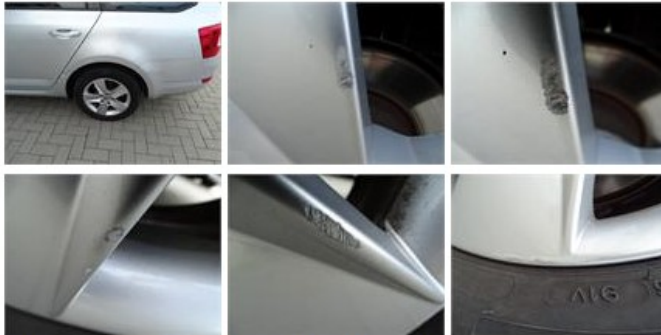
Alloy rim R L, Scratch(es), LI - Repair and paint (complete) 95,00

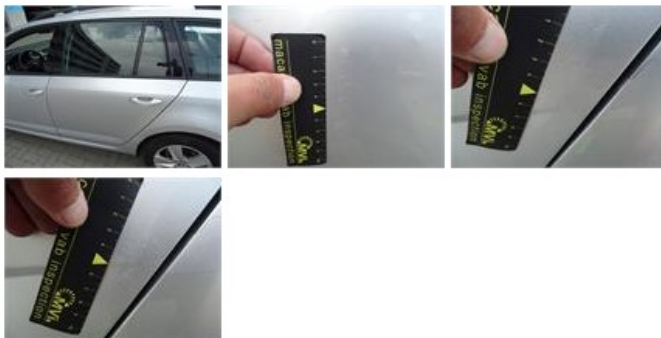
Door R L, Scratch(es), LI - Repair and paint (complete) 318,35

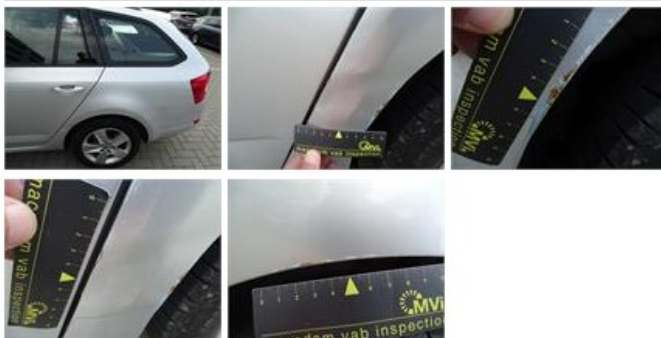
Wing R L, Bump(s) and scratch(es), LI - Repair and paint (complete) 404,20
