VOLKSWAGEN Touran: 1EOJ387

Limited Technical Inspection

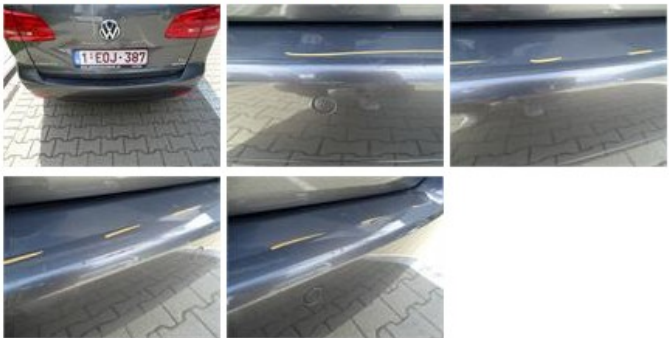
Bumper R, Scratch(es), LI - Repair and paint (complete)		211,80
