<b>BMW 5: 1GVZ927</b>			
Vinnnumber:	<b>WBA5J110X0D336106</b>	Versionname:	<b>5 TOURING 518d 136PK</b>
First Registrationdate:	<b>15/05/2014</b>	Fiscalpower:	
Expertise Mileage:	<b>110756</b>	Power Kw:	<b>100</b>
Bodytype:	<b>Break</b>	Body color:	<b>Dark Grey</b>
Gearbox:	<b>MAN 6 VIT</b>	Paint type:	<b>Metalic</b>
Transmission:		Rims summer:	<b>Aluminium</b>
Fueltype:	<b>Diesel</b>	Oil level:	<b>OK</b>
Battery functioning:	<b>Yes</b>	Parking lot:	<b>4121</b>
Number of doors:	<b>5</b>		
Number of seats:	<b>5</b>		
Number head rests:	<b>5</b>		
Rims summer:	<b>Aluminium</b>		
Category:	<b>Passenger Car</b>		
Oil level:	<b>OK</b>		
Registration Certificate Car (BE):	<b>Yes</b>

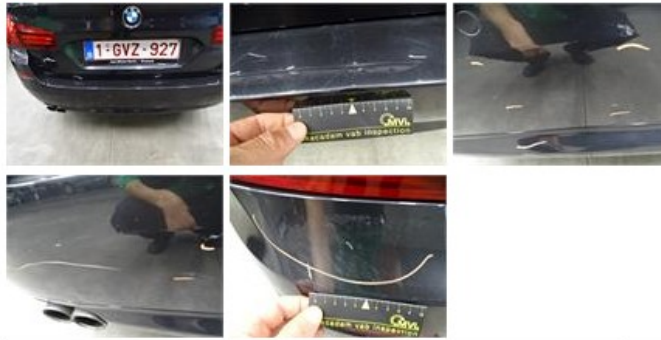
Bumper R, Scratch(es), LI - Repair and paint (complete) 254,16

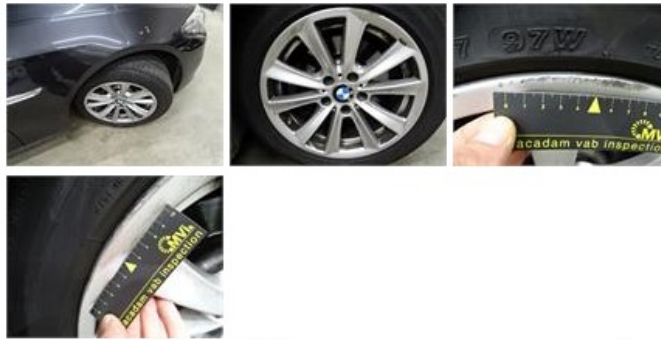
Alloy rim F R, Scratch(es), LI - Repair and paint (complete) 95,00

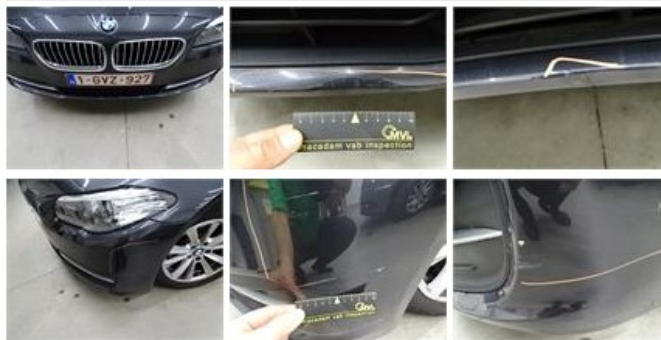
Front bumper, Bump(s) and scratch(es), LI - Repair and paint (complete) 254,16
