| <b>BMW 3: QF8786</b> | | | |
| Vinnumber: | <b>WBA8J31040F696288</b> | Versionname: | <b>3 TOURING 318dX 143PK</b> |

| <b>Limited Technical Inspection</b> | | | |

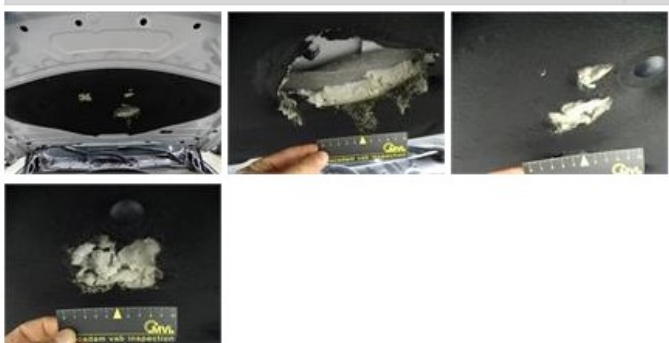
| Protection plate M, Tear, E - Replace | 74,00 |
