FORD Mondeo: 1EWM284

Limited Technical Inspection

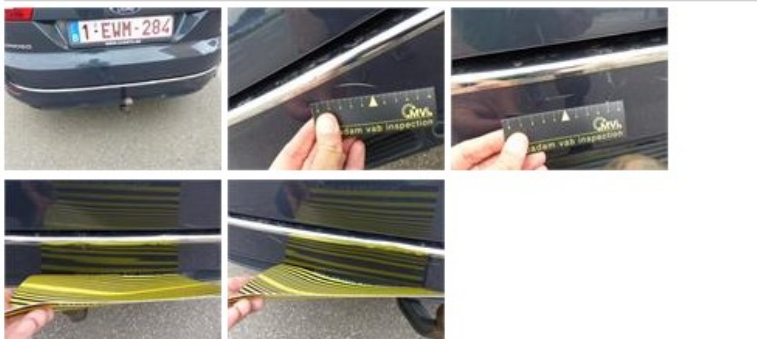
Bumper R, Bump(s) and scratch(es), LI - Repair and paint (complete) 259,80

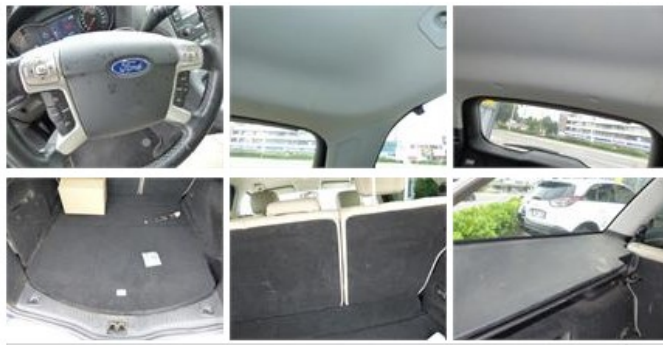
Interior, Dirty, Cleaning 100,00
