MERCEDES A: 1EWC189

Limited Technical Inspection

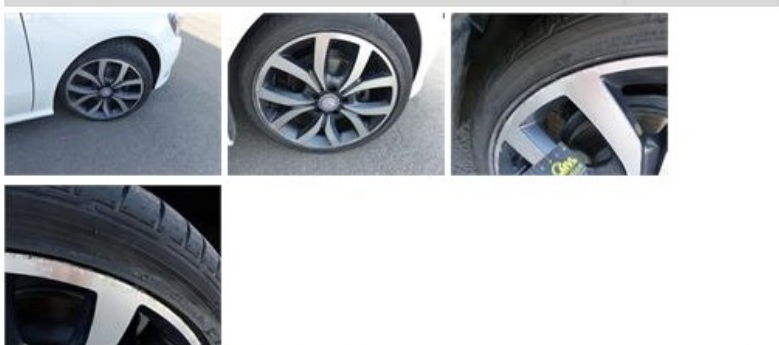
Alloy rim F R polished, Scratch(es), LI - Repair and paint (complete) 95,00

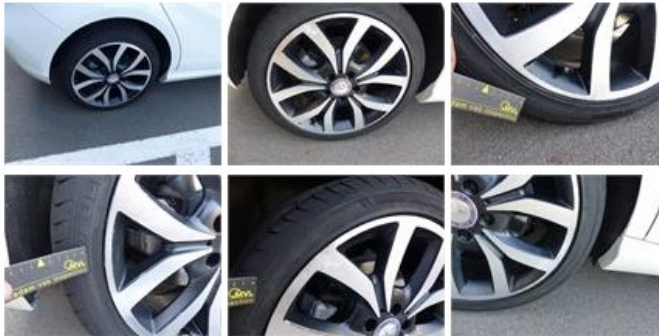
Alloy rim R R polished, Scratch(es), LI - Repair and paint (complete)

95,00

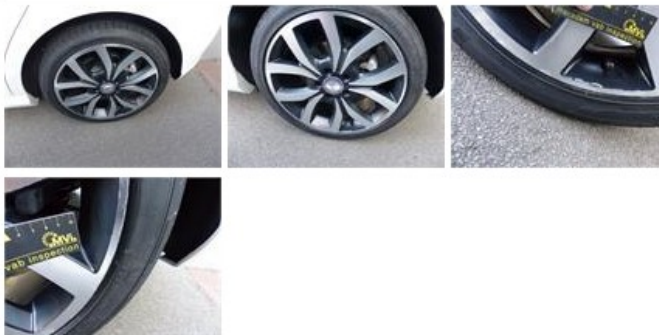
Alloy rim R L polished, Scratch(es), LI - Repair and paint (complete)

95,00

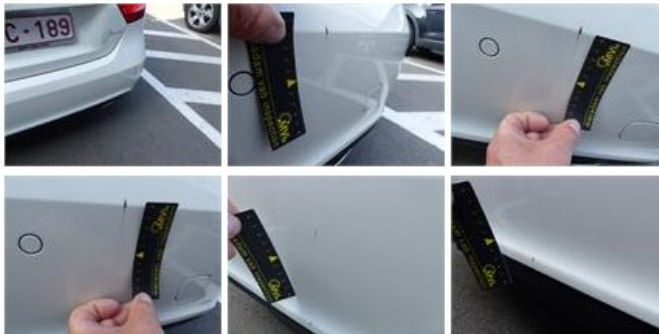
Bumper R, Scratch(es), LI - Repair and paint (complete)

211,80
