**OPEL Astra: 1HGR665**

**Limited Technical Inspection**

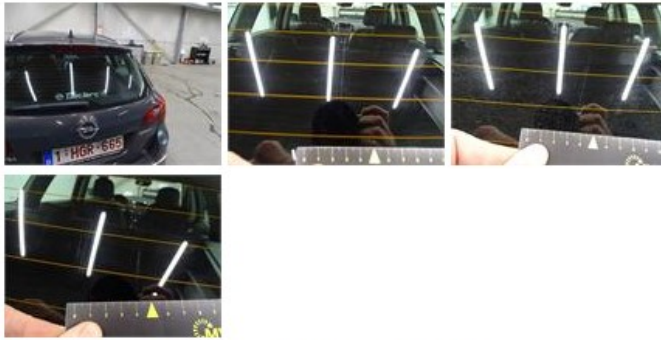
Rear window, Scratch(es), E - Replace 370,00
