**LAND ROVER RANGE ROVER EVOQUE: MB8882**

**Limited Technical Inspection**

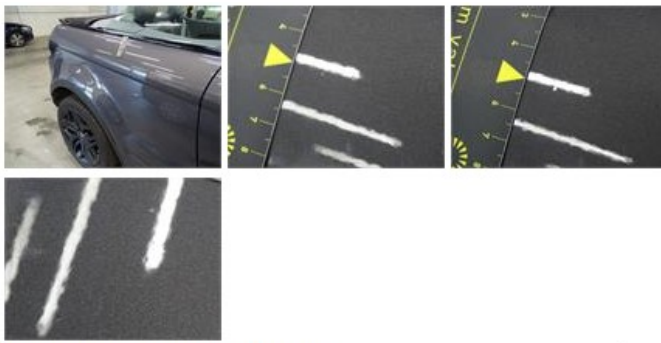
Ignition key, Missing, E - Replace	150,00
<i>No pictures to display</i>	
Wing R R, Bad repair, Acceptable	0,00
