MERCEDES CLA: 1GGL552

| Vinnnumber: | WDD1173011N059846 | Versionname: | CLA BER 200 CDI 136PK |

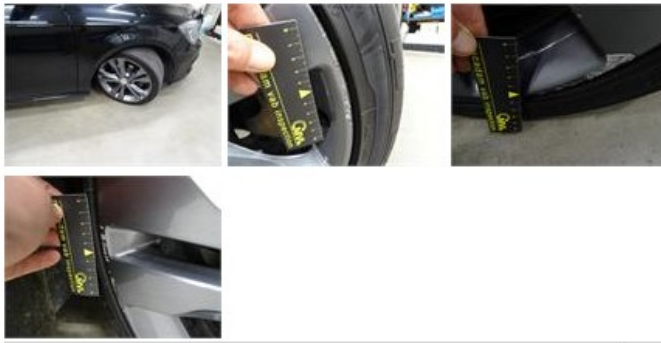
| Alloy rim F R, Scratch(es), LI - Repair and paint (complete) | | | 95,00 |
