**RENAULT Grand Espace: 1HSR505**

**Limited Technical Inspection**

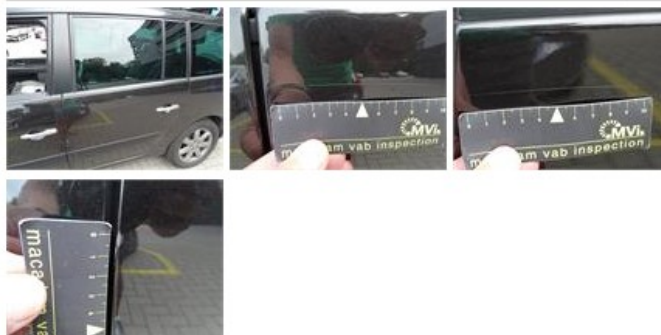
Door R L, Scratch(es), LI - Repair and paint (complete)	382,02
---	--------

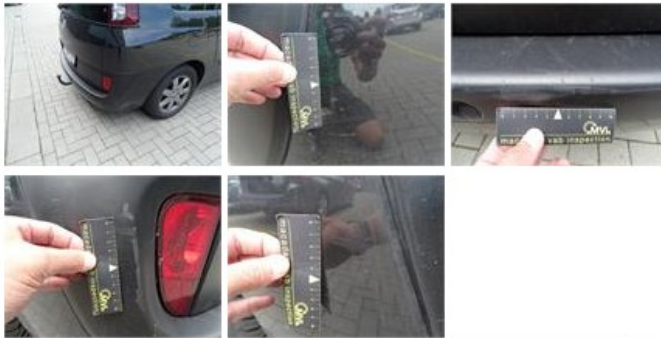
Bumper R, Scratch(es), LI - Repair and paint (complete) 254,16

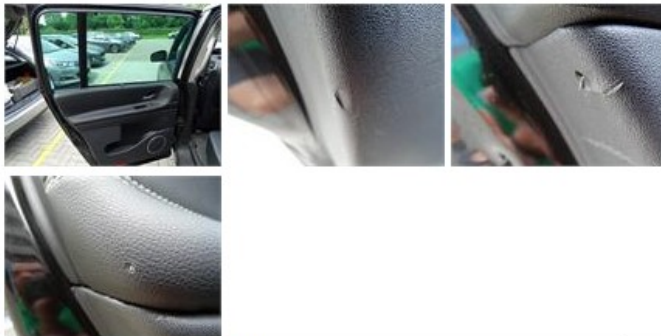
Door panel R L, Damaged, Smart repair 110,64
