OPEL Zafira: 1EXH080

Vinnumber:	WOLPE9EM6D2069008	Versionname:	ZAFIRA TOURER ecoFL.Cosmo St/St.130PK
First Registrationdate:	12/04/2013	Fiscalpower:	
Expertise Mileage:	101836	Power Kw:	96
Bodytype:	Hatchback	Body color:	Grey
Gearbox:	MAN 6 VIT	Paint type:	Metalic
Transmission:	Front	Rims summer:	Aluminium
Fueltype:	Diesel	Oil level:	OK
Maintenance:	UITVOEREN	Parking lot:	3512
Maintenance:	NOT OK		
Battery functioning:	Yes		
Number of doors:	5		
Number of seats:	5		
Number head rests:	5		
Rims summer:	Aluminium		
Category:	Passenger Car		
Oil level:	OK		
Registration Certificate Car (BE):	No

Limited Technical Inspection

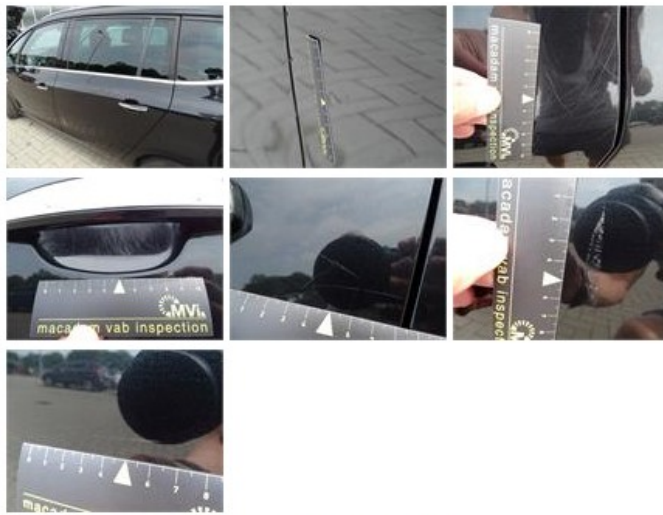
Door R L, Bump(s) and scratch(es), LI - Repair and paint (complete)	318,35
---	--------

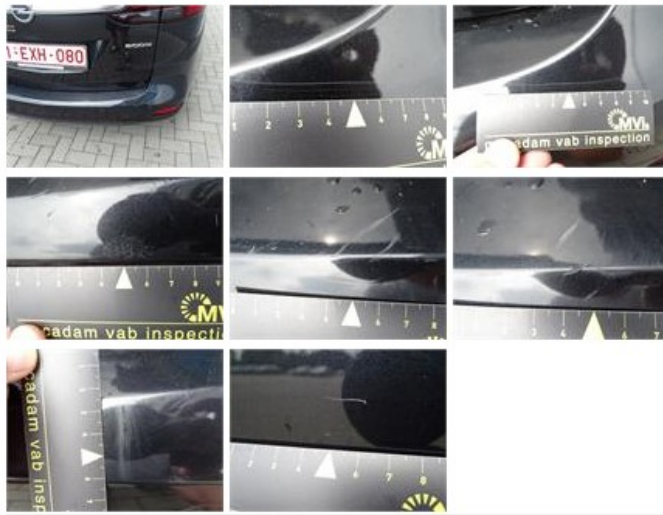
Bumper R, Scratch(es), LI - Repair and paint (complete) 211,80

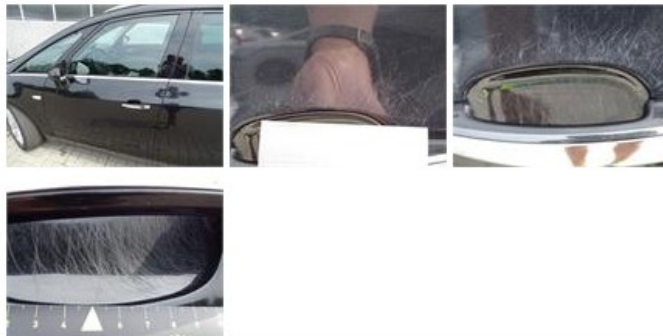
Door F L, Scratch(es), LI - Repair and paint (complete) 318,35

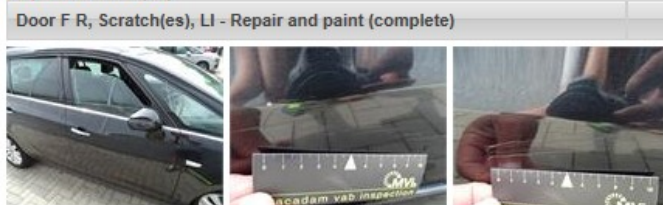
Door F R, Scratch(es), LI - Repair and paint (complete) 318,35
