SKODA Superb: 1HAB012

Limited Technical Inspection

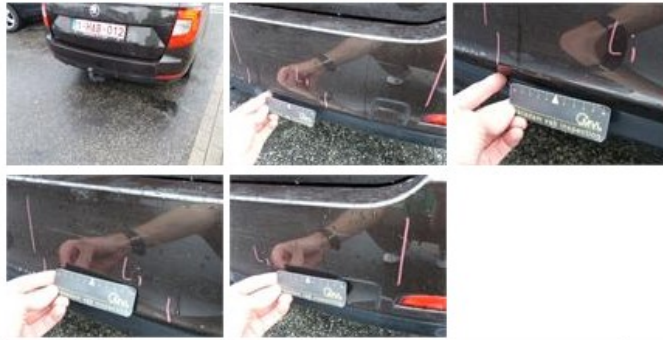
Bumper R, Scratch(es), LI - Repair and paint (complete)

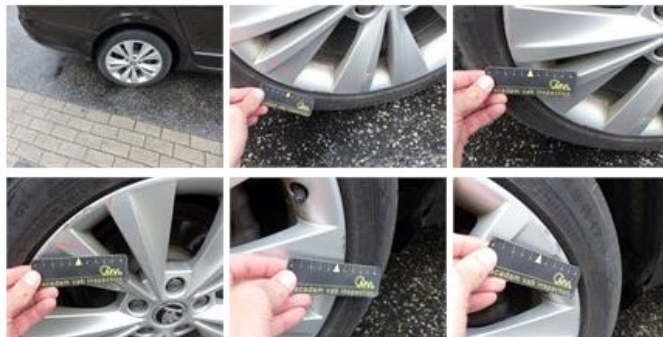
Alloy rim R R, Scratch(es), LI - Repair and paint (complete)

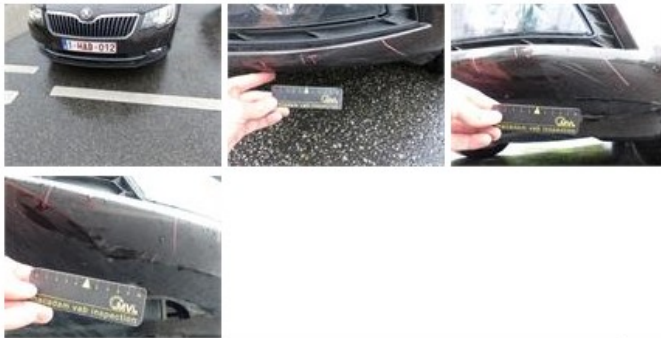
Front bumper, Scratch(es), It - Spot repair	115,56
---	--------
