<b>SKODA Superb: 1CRP346</b>			
Vinnnumber:	<b>TMBAE73T3C9047950</b>	Versionname:	<b>SUPERB BER Ambiente DPF 140PK</b>
First Registrationdate:	<b>10/02/2012</b>	Fiscalpower:	
Expertise Mileage:	<b>177876</b>	Power Kw:	<b>103</b>
Bodytype:		Body color	<b>Brown</b>
Gearbox:	<b>MAN 6 VIT</b>	Paint type	<b>Metalic</b>
Transmission:		Rims summer	<b>Aluminium</b>
Fueltype:	<b>Diesel</b>	Oil level	<b>OK</b>
Battery functioning	<b>Yes</b>	Parking lot	<b>1506</b>
Number of doors	<b>4</b>		
Number of seats	<b>5</b>		
Number head rests	<b>5</b>		
Rims summer	<b>Aluminium</b>		
Category	<b>Passenger Car</b>		
Oil level	<b>OK</b>

<b>Limited Technical Inspection</b>			
Airco functioning	<b>OK</b>	Battery functioning	<b>Yes</b>
Tires wear profile	<b>OK</b>	Power steering	<b>Yes</b>
Idle position	<b>OK</b>	Sound engine	<b>OK</b>
Engine startingtime	<b>OK</b>	Clutch test	<b>OK</b>
Exhaust gass	<b>OK</b>	Wiper fluid level	<b>OK</b>
Handbrake	<b>OK</b>	Transmission	<b>OK</b>
		Lighting	<b>OK</b>
		Wiperblades	<b>OK</b>

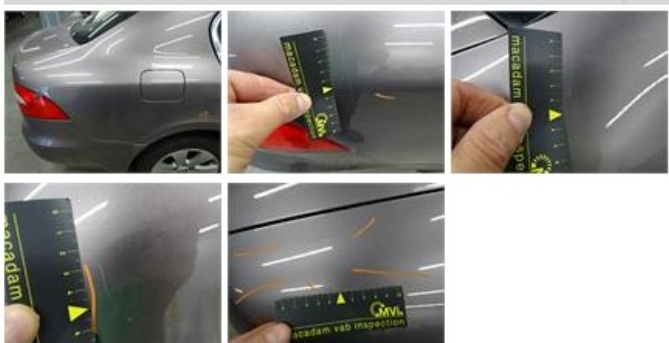
Total cost ex VAT	<b>751,86</b>
Wing R R, Scratch(es), LI - Repair and paint (complete)	<b>369,84</b>

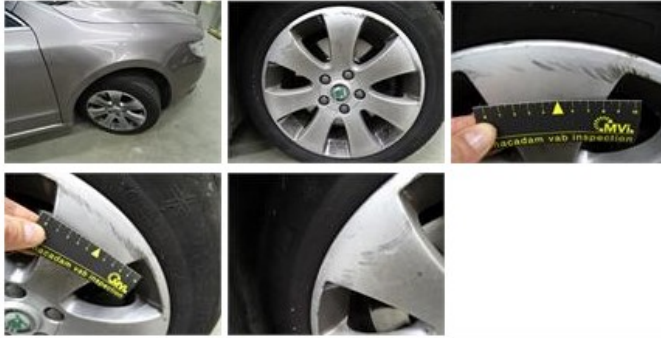
Alloy rim F R, Scratch(es), LI - Repair and paint (complete) 0,00

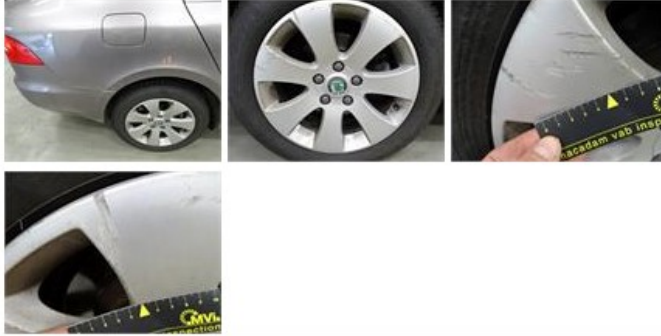
Alloy rim R R, Scratch(es), LI - Repair and paint (complete) 0,00

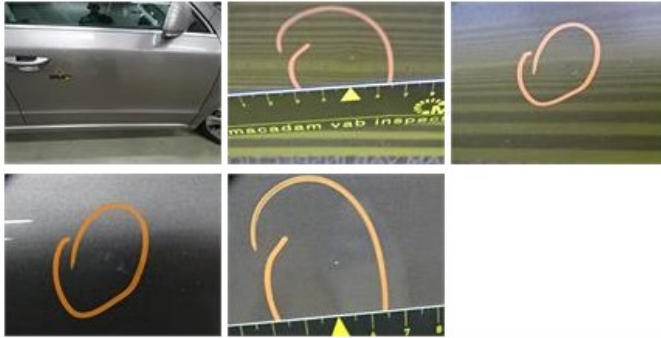
Door F R, Bump(s) and scratch(es), LI - Repair and paint (complete) 382,02
