<b>SKODA Octavia: 1DOE956</b>			
Vinnnumber:	<b>TMBHT21Z7D2015530</b>	Versionname:	<b>OCTAVIA COMBI GTec Ambition DPF 105PK</b>
First Registrationdate:	<b>5/07/2012</b>	Fiscalpower:	
Expertise Mileage:	<b>164696</b>	Power Kw:	<b>77</b>
Bodytype:	<b>Break</b>	Body color:	<b>Beige</b>
Gearbox:	<b>MAN 5 VIT</b>	Paint type:	<b>Metalic</b>
Transmission:		Rims summer:	<b>Aluminium</b>
Fueltype:	<b>Diesel</b>	Oil level:	<b>OK</b>
Battery functioning:	<b>Yes</b>	Parking lot:	<b>1425</b>
Number of doors:	<b>5</b>		
Number of seats:	<b>5</b>		
Number head rests:	<b>5</b>		
Rims summer:	<b>Aluminium</b>		
Category:	<b>Passenger Car</b>		
Oil level:	<b>OK</b>		
Registration Certificate Car (BE):	<b>Yes</b>

<b>Limited Technical Inspection</b>			
Airco functioning	<b>OK</b>	Battery functioning	<b>Yes</b>
Tires wear profile	<b>OK</b>	Power steering	<b>Yes</b>
Idle position	<b>OK</b>	Sound engine	<b>OK</b>
Engine startingtime	<b>OK</b>	Clutch test	<b>OK</b>
Exhaust gass	<b>OK</b>	Wiper fluid level	<b>NOT OK</b>
Handbrake	<b>OK</b>	Transmission	<b>OK</b>
		Lighting	<b>OK</b>
		Wiperblades	<b>OK</b>

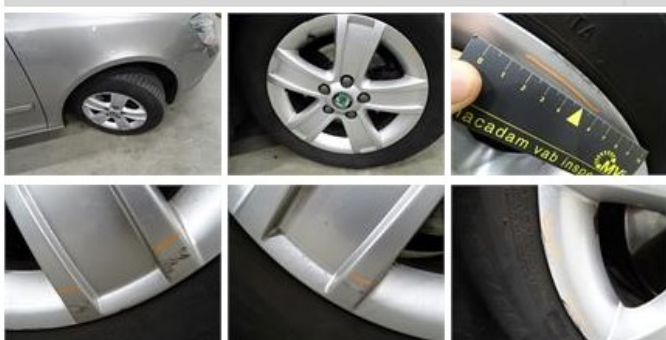
Total cost ex VAT	<b>1816,90</b>
Alloy rim F R, Scratch(es), LI - Repair and paint (complete)	<b>95,00</b>

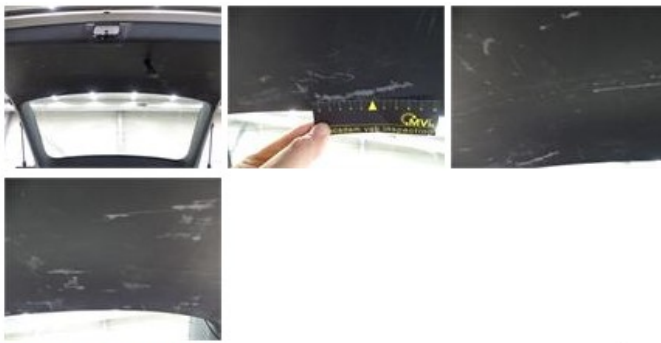
Bumper F L, Scratch(es), Acceptable	<b>0,00</b>
<i>No pictures to display</i>	
Trunk lid covering R, Scratch(es), Smart repair	<b>110,64</b>

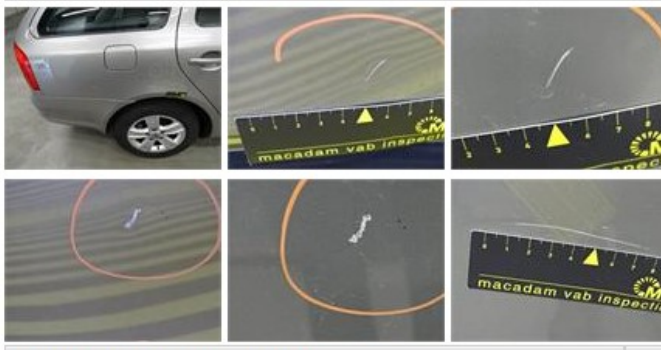
Wing R R, Bump(s) and scratch(es), LI - Repair and paint (complete) 308,20

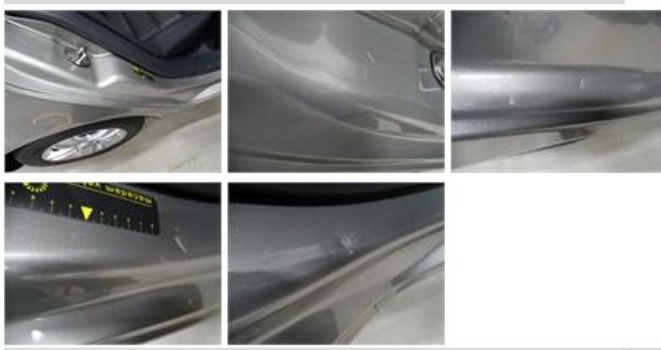
Rocker panel inner R R, Bump(s) and scratch(es), LI - Repair and paint (complete) 115,56

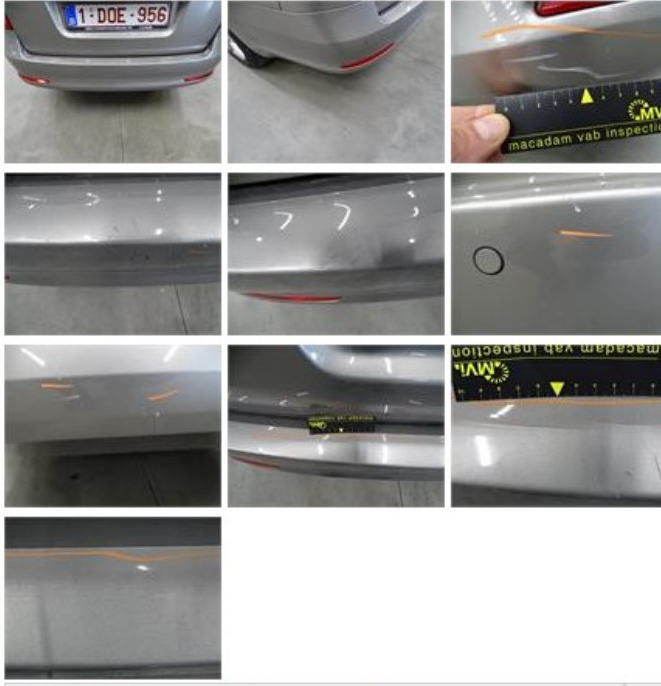
Bumper R, Bump(s) and scratch(es), LI - Repair and paint (complete) 211,80

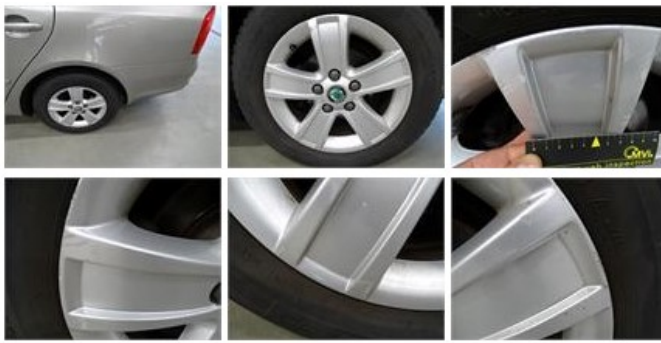
Alloy rim R L, Scratch(es), LI - Repair and paint (complete) 95,00

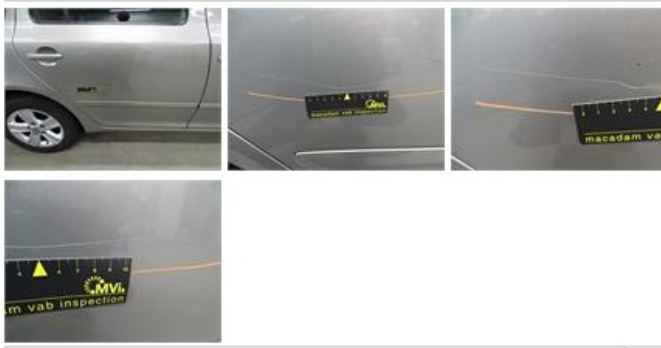
Door R R, Scratch(es), LI - Repair and paint (complete) 318,35
