**VOLVO XC90: PII423**

**Limited Technical Inspection**

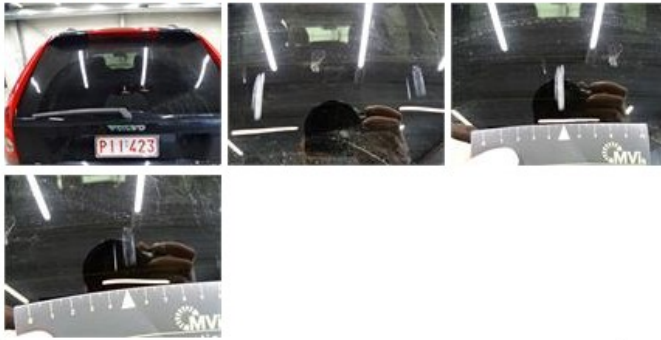
Rear window, Scratch(es), E - Replace 420,00

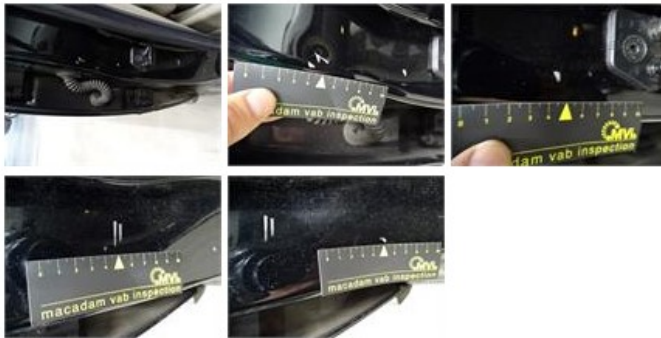
Rocker panel inner F R, Bump(s) and scratch(es), LI - Repair and paint (complete) 115,56
