VOLKSWAGEN Touran: 1FWW041			
Vinnnumber:	WVGZZZ1TZEW036260	Versionname:	TOURAN Trendline BMT Start/Stop 105PK
First Registrationdate:	21/11/2013	Fiscalpower:	
Expertise Mileage:	82882	Power Kw:	77
Bodytype:		Body color:	Light Blue
Gearbox:	MAN 6 VIT	Paint type:	Metalic
Transmission:		Rims summer:	Steel
Fueltype:	Diesel	Oil level:	OK
Battery functioning:	Yes	Parking lot:	4830
Number of doors:	5		
Number of seats:	5		
Number head rests:	5		
Rims summer:	Steel		
Category:	Passenger Car		
Oil level:	OK		
Registration Certificate Car (BE):	Yes

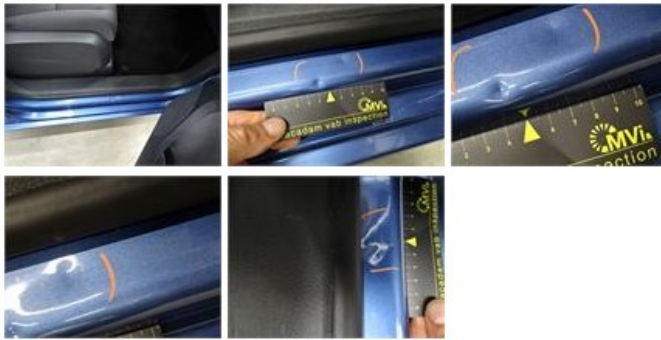
Rocker panel inner F R, Bump(s) and scratch(es), LI - Repair and paint (complete) 115,56

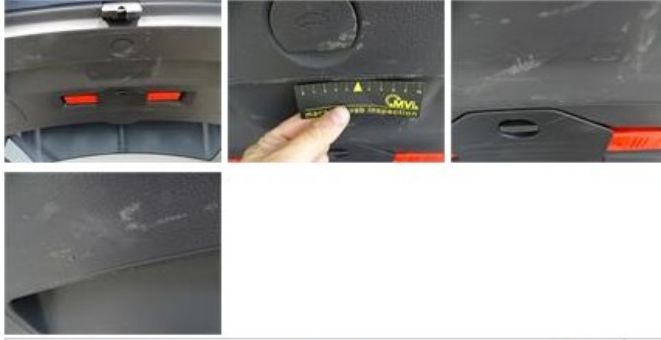
Rear bulkhead lining, Scratch(es), Smart repair 110,64
