BMW 3: 1GHS497

Limited Technical Inspection

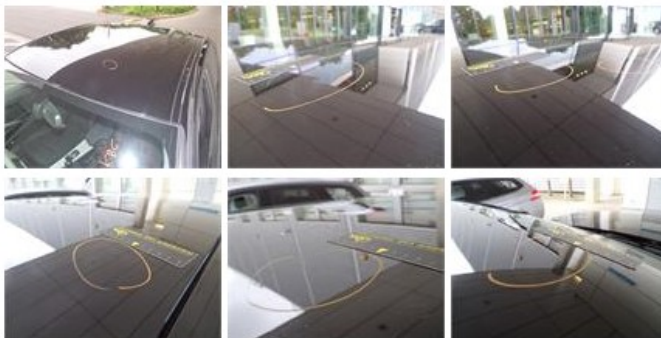
Roof, Hail damage, LI - Repair and paint (complete) 481,50
