**BMW 3: 1EMF069**

**Limited Technical Inspection**

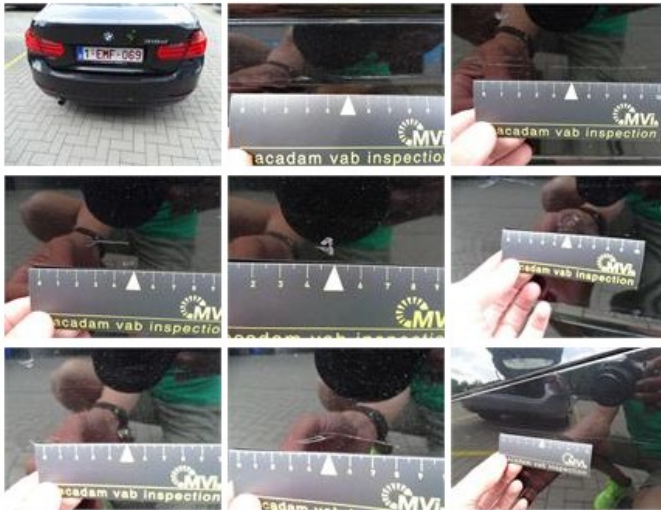
Bumper R, Scratch(es), LI - Repair and paint (complete) 211,80

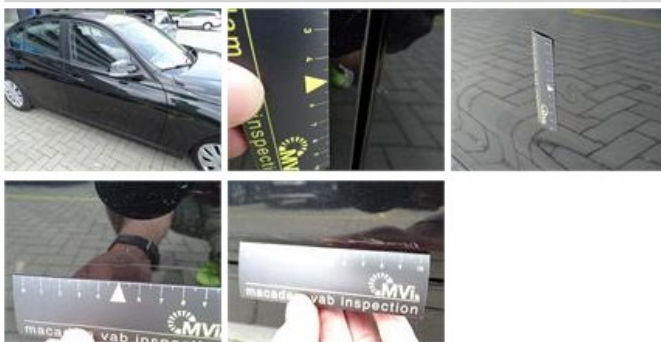
Door F R, Bump(s) and scratch(es), LI - Repair and paint (complete) 318,35
