BMW 3: 1FEB440

Limited Technical Inspection

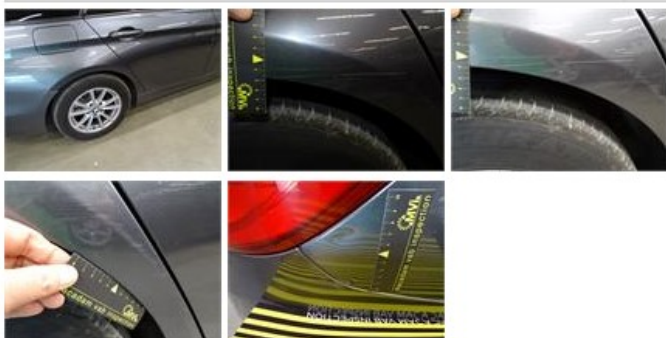
Wing R R, Bump(s) and scratch(es), LI - Repair and paint (complete)	308,20
---	---------------
