BMW 3: 1FQP929

Limited Technical Inspection

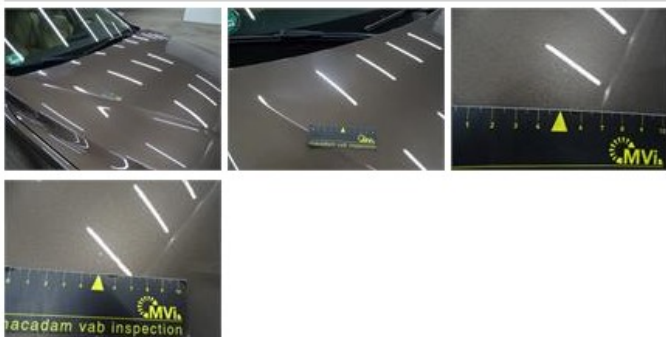
Bonnet, Bad repair, Acceptable	0,00
--------------------------------	-------------
