BMW 5: HG7613

Limited Technical Inspection

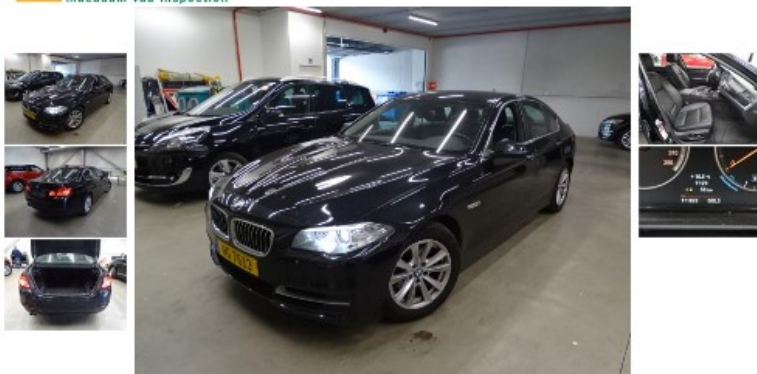
Vinnumber:	WBA5C110X0D035880	Versionname:	5 BER 518d 143PK
First Registrationdate:	18/06/2014	Fiscalpower:	
Expertise Mileage:	111823	Power Kw:	105
Bodytype:		Body color:	Black
Gearbox:	MAN 6 VIT	Paint type:	Metalic
Transmission:	Back	Rims summer:	Aluminium
Fueltype:	Diesel	Oil level:	OK
Battery functioning:	Yes	Parking lot:	3228
Number of doors:	4		
Number of seats:	5		
Number head rests:	5		
Rims summer:	Aluminium		
Category:	Passenger Car		
Oil level:	OK		
Registration Certificate Car (BE):	Yes
