CITROEN C5: 1EUJ466

Limited Technical Inspection

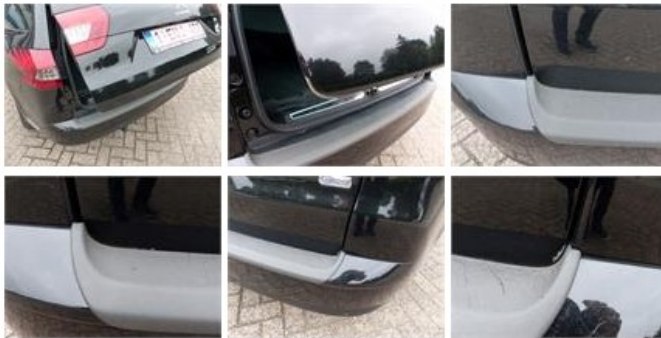
Tailgate, Rust, LI - Repair and paint (complete) 301,68
