BMW 3: HK4015

| Vinnnumber: | WBA3D51030J458586 | Versionname: | 3 BER 320dXA 184PK Aut. |

Limited Technical Inspection

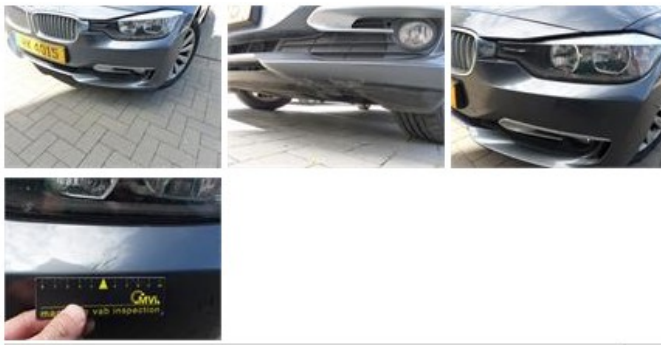
| Front bumper, Scratch(es), LI - Repair and paint (complete) | | 211,80 |

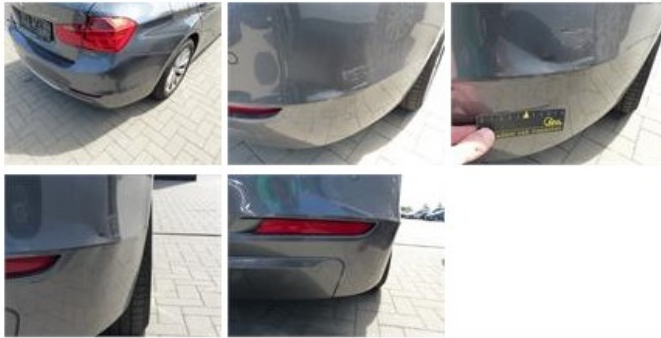
| Bumper R, Bump(s) and scratch(es), Le - Replace and paint | 651,00 |
