MERCEDES E BREAK: 1KJN674

Vinnumber:	WDD2122981B186872	Versionname:	2.1 E 300 BLUETEC HYBRID AVANTGARDE AUTO
First Registrationdate:	12/05/2015	Fiscalpower:	
Expertise Mileage:	63576	Power Kw:	170
Bodytype:		Body color:	Silver
Gearbox:	Automatic	Paint type:	Metalic
Transmission:	Back	Rims summer:	Aluminium
Fueltype:	Diesel	Oil level:	OK
Maintenance:	- 10 DAGEN	Parking lot:	2307
Maintenance:	NOT OK		
Battery functioning:	Yes		
Number of doors:	4		
Number of seats:	5		
Number head rests:	5		
Rims summer:	Aluminium		
Category:	Passenger Car		
Oil level:	OK		
Registration Certificate Car (BE):	Yes

Limited Technical Inspection

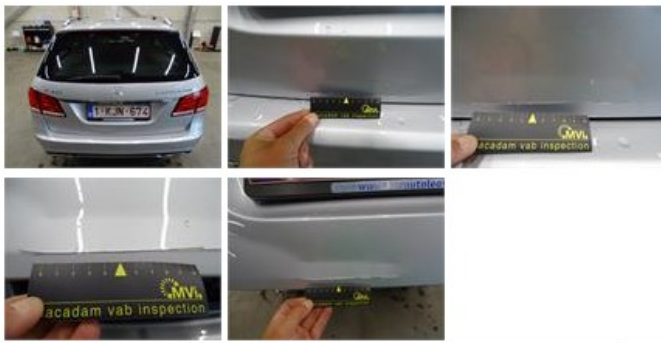
Tailgate, Bump(s) and scratch(es), LI - Repair and paint (complete)	506,02
---	--------

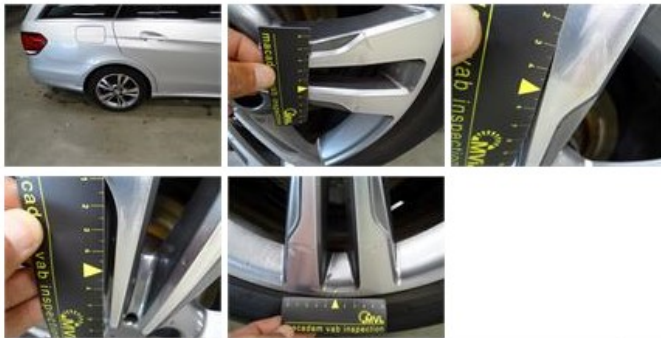
Alloy rim R R polished, Scratch(es), LI - Repair and paint (complete) 95,00

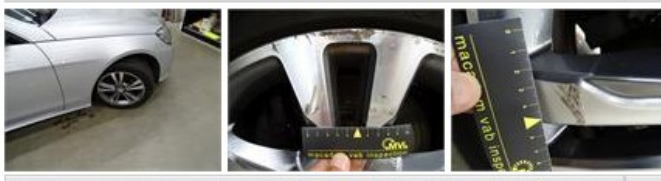
Alloy rim F R polished, Scratch(es), LI - Repair and paint (complete) 95,00

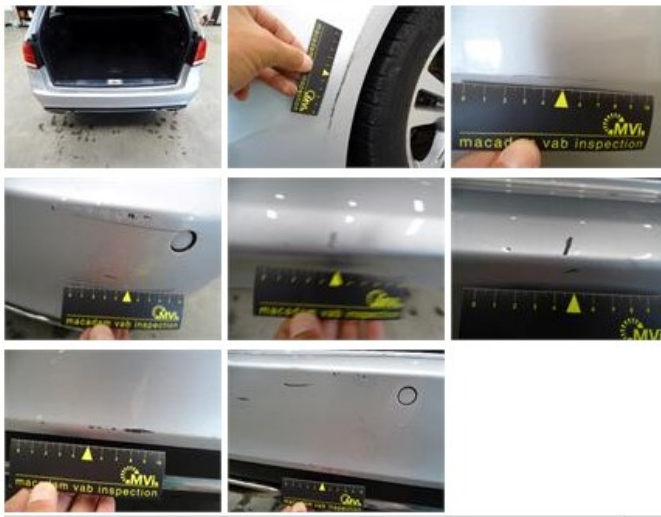
Bumper R, Scratch(es), LI - Repair and paint (complete) 254,16
