FORD Focus: 1ELK031

Limited Technical Inspection

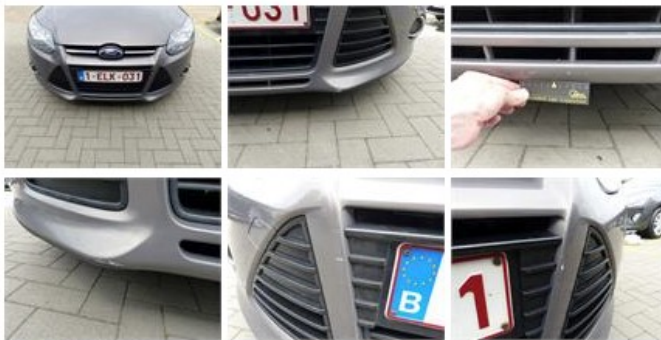
Front bumper, Scratch(es), LI - Repair and paint (complete) 211,80
