RENAULT Clio: 1GJA310			
Vinnumber:	<b>VF17R040H50249868</b>	Versionname:	<b>CLIO IV BRE Expression</b>
First Registrationdate:	<b>20/02/2014</b>	Fiscalpower:	<b>75PK</b>
Expertise Mileage:	<b>109111</b>	Power Kw:	<b>55</b>
Bodytype:		Body color:	<b>Black</b>
Gearbox:	<b>MAN 5 VIT</b>	Paint type:	<b>Metalic</b>
Transmission:		Rims summer:	<b>Steel</b>
Fueltype:	<b>Diesel</b>	Oil level:	<b>OK</b>
Battery functioning:	<b>Yes</b>	Parking lot:	<b>2633</b>
Number of doors:	<b>5</b>		
Number of seats:	<b>5</b>		
Number head rests:	<b>4</b>		
Rims summer:	<b>Steel</b>		
Category:	<b>Passenger Car</b>		
Oil level:	<b>OK</b>		
Registration Certificate Car (BE):	<b>Yes</b>

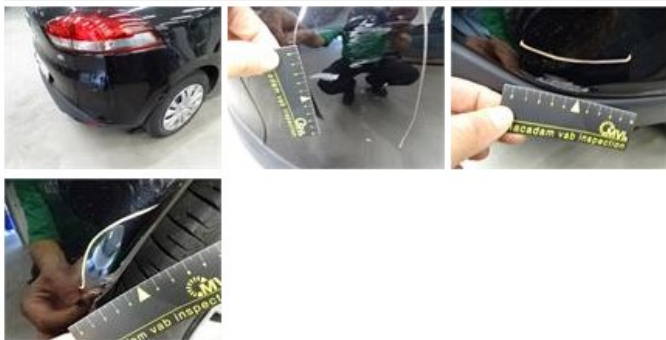
Assistance equipment	
Jack	<b>Yes</b>
Total cost ex VAT	<b>786,24</b>
Wheel cover F L, Scratch(es), Acceptable	<b>0,00</b>
<i>No pictures to display</i>	
Bumper corner R R, Scratch(es), It - Spot repair	<b>115,56</b>

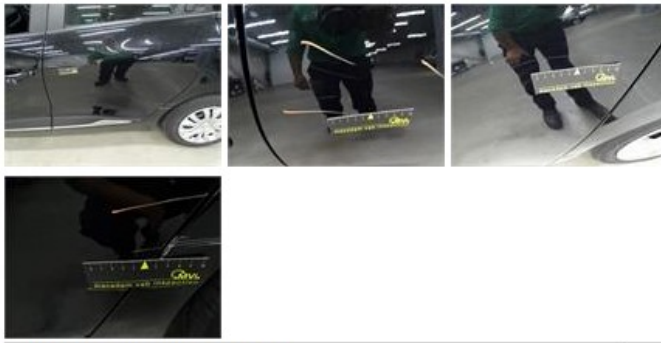
Door R L, Scratch(es), LI - Repair and paint (complete)	<b>254,68</b>
---	---------------

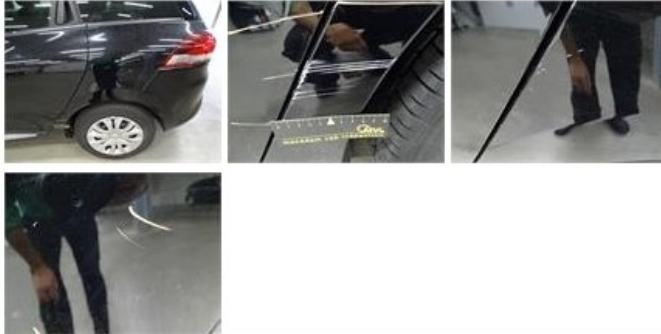
Wing R L, Bump(s) and scratch(es), LI - Repair and paint (complete) 246,56

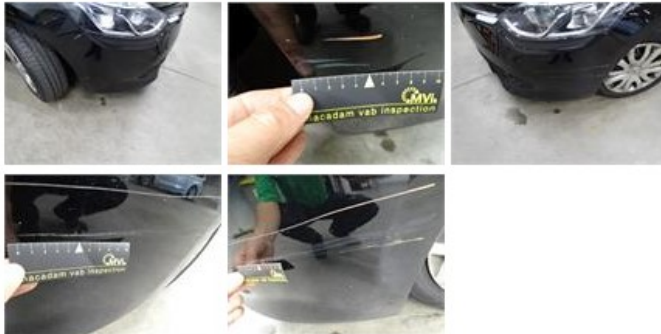
Front bumper, Scratch(es), LI - Repair and paint (complete) 169,44
