**MERCEDES VITO: TXAB631**

**Limited Technical Inspection**

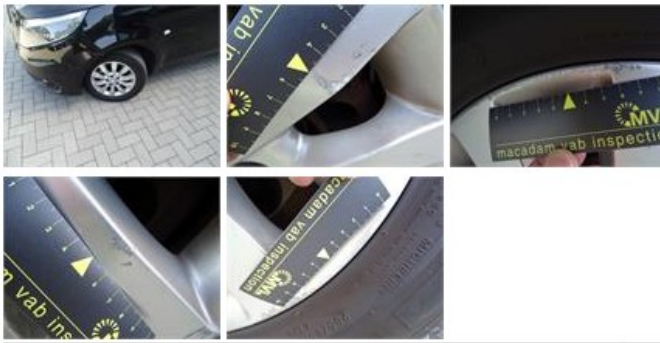
Alloy rim F L, Scratch(es), LI - Repair and paint (complete) 95,00

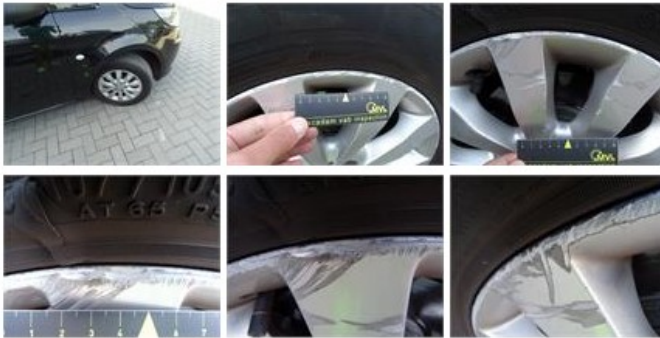
Alloy rim F R, Damaged, E - Replace 182,40

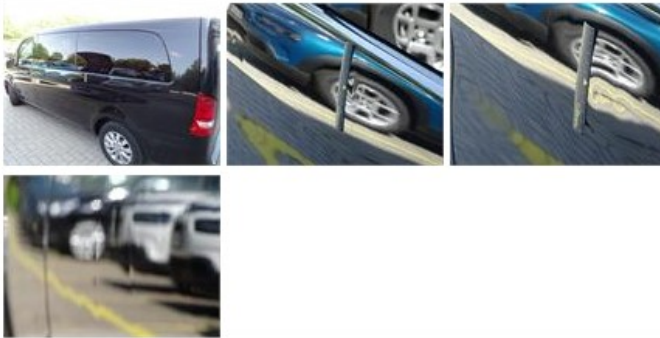
Wing R L, Bump(s) and scratch(es), LI - Repair and paint (complete) 231,15

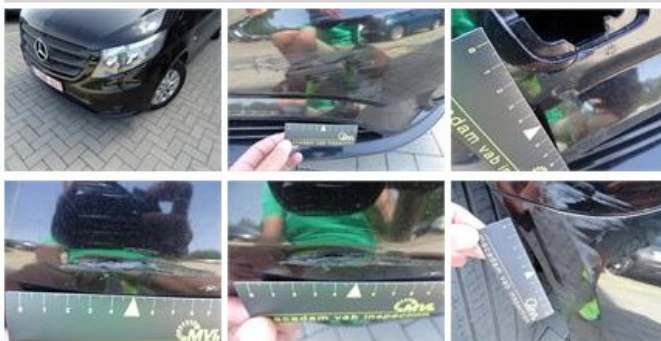
Front bumper, Damaged, Le - Replace and paint 575,25
