**RENAULT Master 33 L2H2: AP4914**

**Limited Technical Inspection**

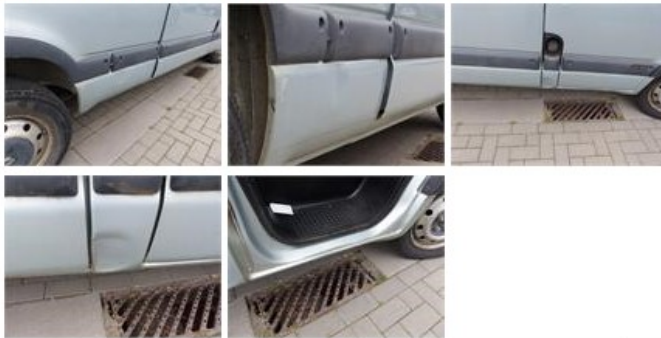
Sill outer R, Bump(s) and scratch(es), LI - Repair and paint (complete)

352,88

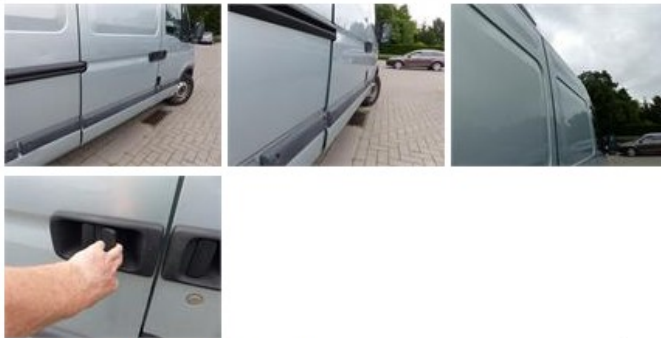
Door R R, Unclapsed, N - Mount/Dismount

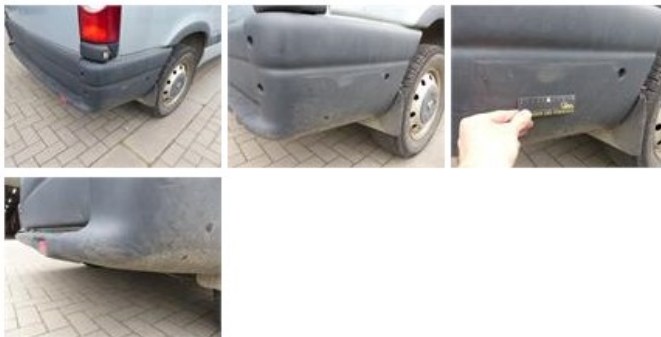
Bumper corner R R, Scratch(es), E - Replace

148,00

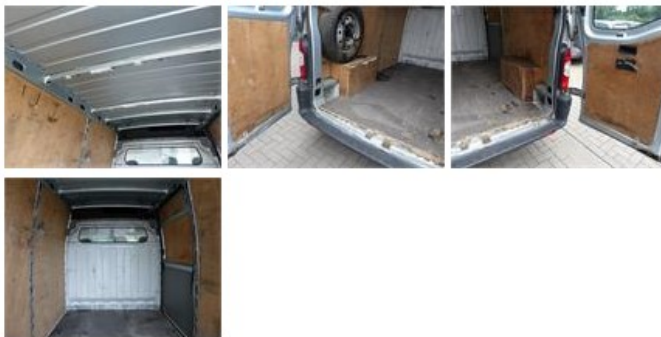
Trunk lid covering R, Damaged, Acceptable
