SEAT Alhambra: 1GVG491			
Vinnumber:	VSSZZZ7NZEV518463	Versionname:	ALHAMBRA
First Registrationdate:	9/05/2014	Fiscalpower:	E-Ecom.Exec.Limit.136PK
Expertise Mileage:	158763	Power Kw:	100
Bodytype:	MPV	Body color:	Blue
Gearbox:	MAN 6 VIT	Paint type:	Metalic
Transmission:	Front	Rims summer:	Aluminium
Fueltype:	Diesel	Oil level:	OK
Battery functioning:	Yes	Parking lot:	2625
Number of doors:	5		
Number of seats:	7		
Number head rests:	7		
Rims summer:	Aluminium		
Category:	Passenger Car		
Oil level:	OK		
Registration Certificate Car (BE):	Yes

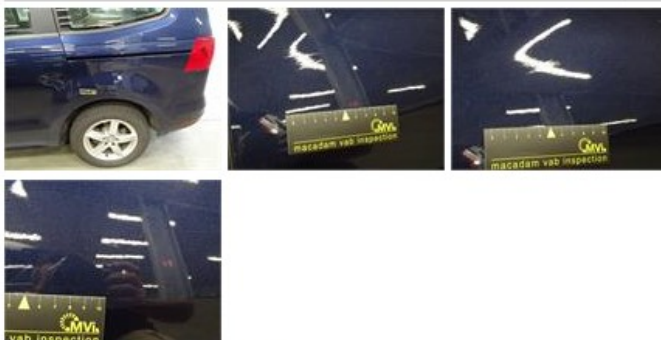
Assistance equipment	
Total cost ex VAT	693,36
Wing R L, Bad repair, Paint	0,00
