VOLVO S60: 1EUD439

Limited Technical Inspection

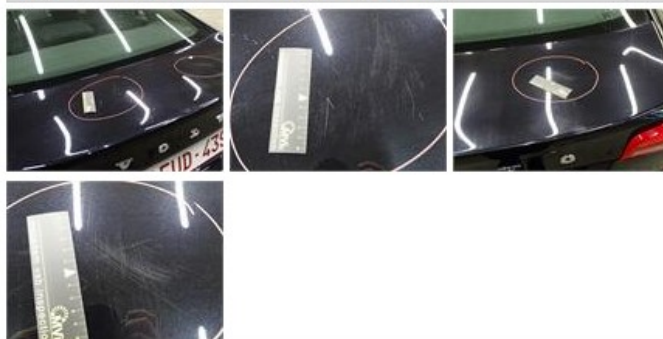
Tailgate, Scratch(es), LI - Repair and paint (complete) 301,68

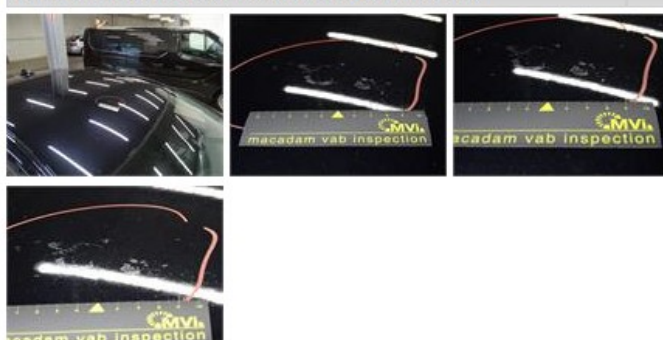
Roof, Chemical pollution, LI - Repair and paint (complete) 481,50
