## VOLVO V60: 1LJZ935

## Limited Technical Inspection

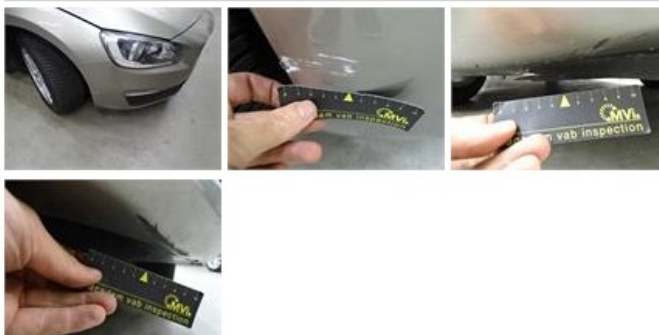
Front bumper, Scratch(es), LI - Repair and paint (complete)	211,80
---	--------
