VOLVO S60: 1JLV324

Limited Technical Inspection

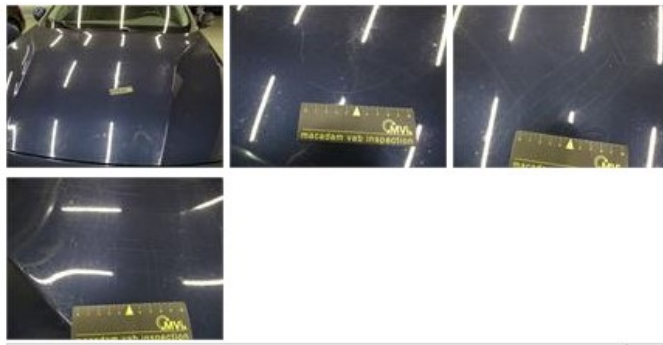
Bonnet, Scratch(es), LI - Repair and paint (complete)	290,08
---	---------------

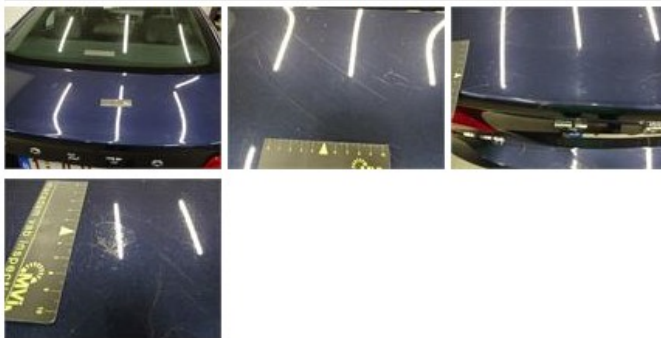
Tailgate, Scratch(es), LI - Repair and paint (complete) 301,68
