VOLKSWAGEN Golf: 1FLN154

Limited Technical Inspection

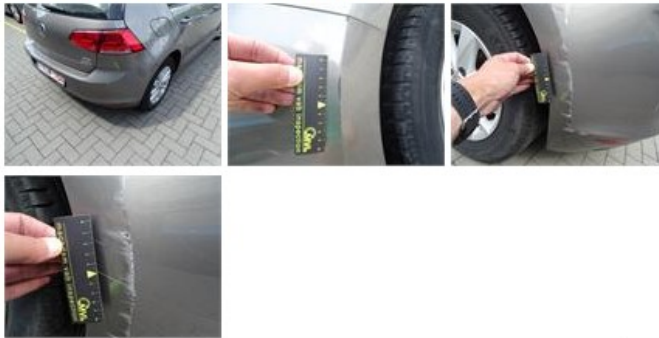
Bumper R, Scratch(es), LI - Repair and paint (complete)

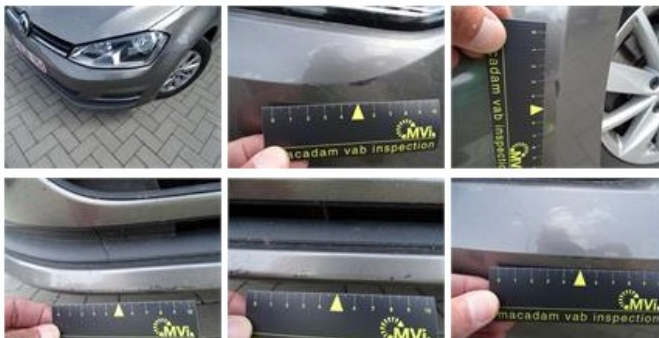
Front bumper, Scratch(es), LI - Repair and paint (complete)

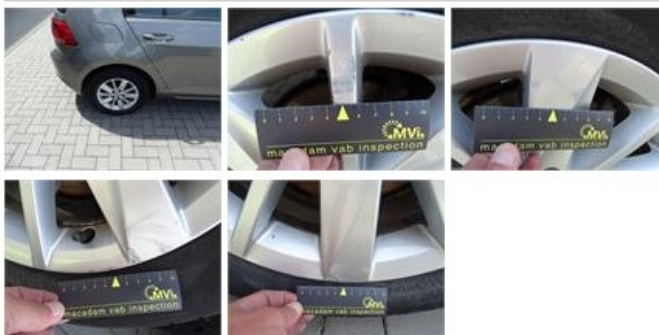
Alloy rim R R, Scratch(es), LI - Repair and paint (complete)
