BMW 5 TOURING: 1JXU153

Limited Technical Inspection

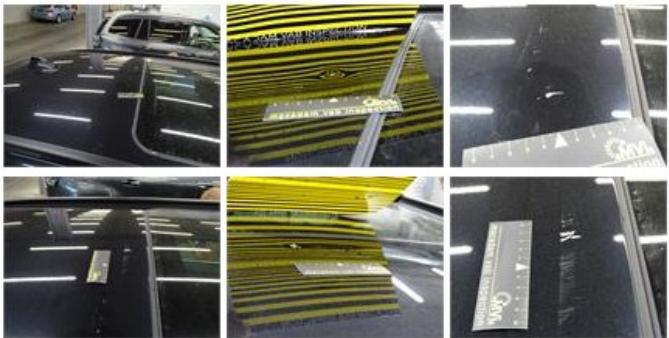
Door F L, Scratch(es), Acceptable		0,00
<i>No pictures to display</i>		
Wing R R, Scratch(es), Acceptable		0,00
<i>No pictures to display</i>		
Boot cover, Scratch(es), Acceptable		0,00
<i>No pictures to display</i>		
Roof, Bump(s) and scratch(es), LI - Repair and paint (complete)		673,80

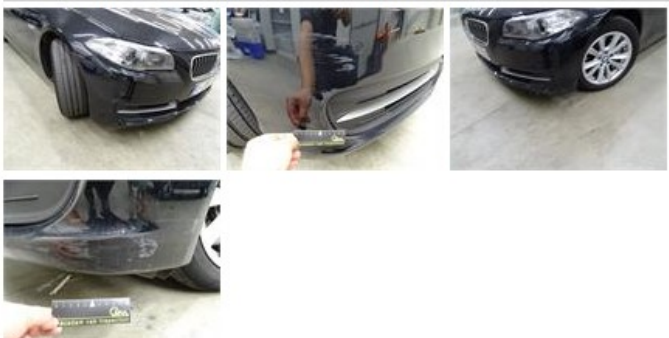
Rearview mirror housing L, Scratch(es), Acceptable		0,00
<i>No pictures to display</i>		
Windscreen, Stone chip(s), Acceptable		0,00
<i>No pictures to display</i>		
Rocker panel inner R R, Scratch(es), Acceptable		0,00
<i>No pictures to display</i>		
Bonnet, Stone chip(s), Acceptable		0,00
<i>No pictures to display</i>		
Front bumper, Scratch(es), LI - Repair and paint (complete)		254,16
