BMW 1: 1GVB819			
Vinnnumber:	<b>WBA1C91030P691754</b>	Versionname:	<b>1 HATCH 116d Eff.Dyn.Ed. 116PK</b>
First Registrationdate:	<b>8/05/2014</b>	Fiscalpower:	
Expertise Mileage:	<b>82865</b>	Power Kw:	<b>85</b>
Bodytype:	<b>Hatchback</b>	Body color:	<b>Dark Blue</b>
Gearbox:	<b>MAN 6 VIT</b>	Paint type:	<b>Metalic</b>
Transmission:	<b>Back</b>	Rims summer:	<b>Aluminium</b>
Fueltype:	<b>Diesel</b>	Oil level:	<b>OK</b>
Battery functioning:	<b>Yes</b>	Parking lot:	<b>1233</b>
Number of doors:	<b>5</b>		
Number of seats:	<b>5</b>		
Number head rests:	<b>5</b>		
Rims summer:	<b>Aluminium</b>		
Category:	<b>Passenger Car</b>		
Oil level:	<b>OK</b>		
Registration Certificate Car (BE):	<b>Yes</b>

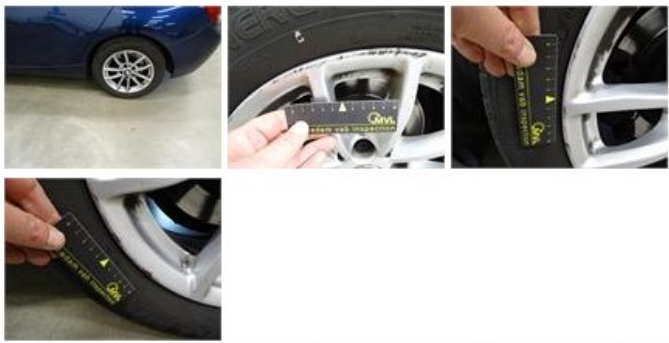
Assistance equipment			
Repair kit	<b>Yes</b>	Compressor	<b>Yes</b>
Total cost ex VAT			<b>1040,65</b>
Alloy rim R L, Scratch(es), LI - Repair and paint (complete)			<b>95,00</b>

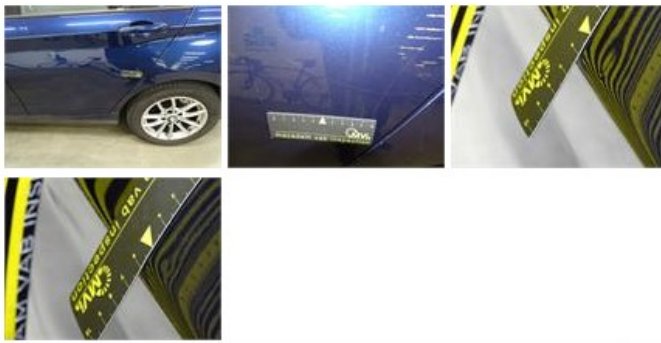
Door R L, Bump(s) and scratch(es), LI - Repair and paint (complete)	<b>318,35</b>
---	---------------
