MERCEDES B: CR0003

Limited Technical Inspection

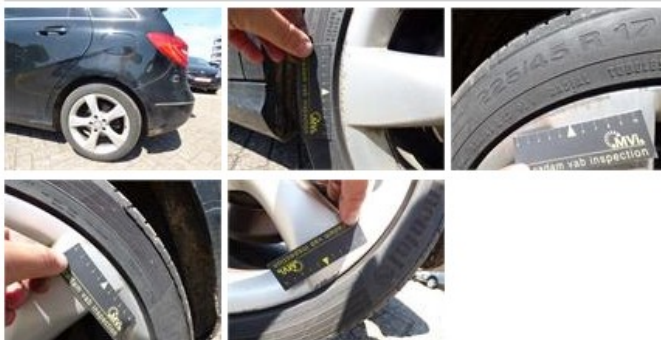
Total cost ex VAT	1542,68
Alloy rim R L, Scratch(es), LI - Repair and paint (complete)	95,00

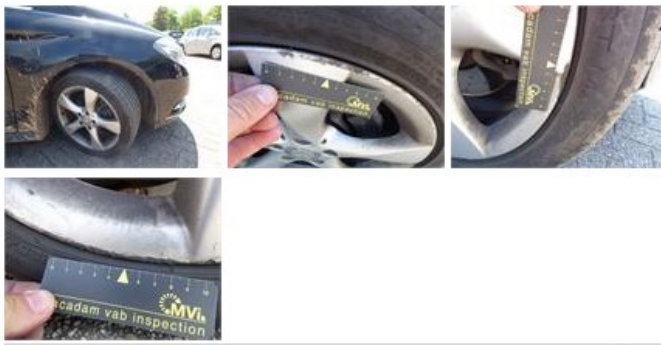
Alloy rim F R, Scratch(es), LI - Repair and paint (complete)	95,00
--	-------

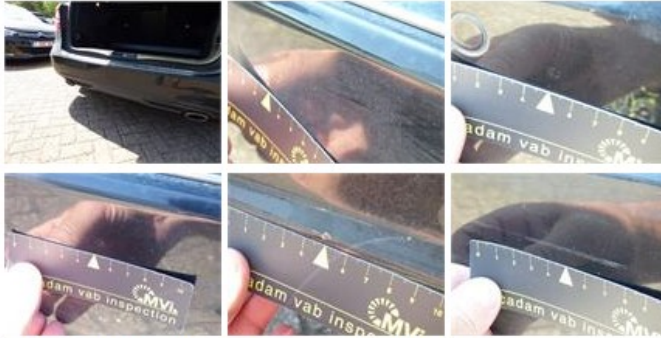
Bumper R, Damaged, LI - Repair and paint (complete) 211,80

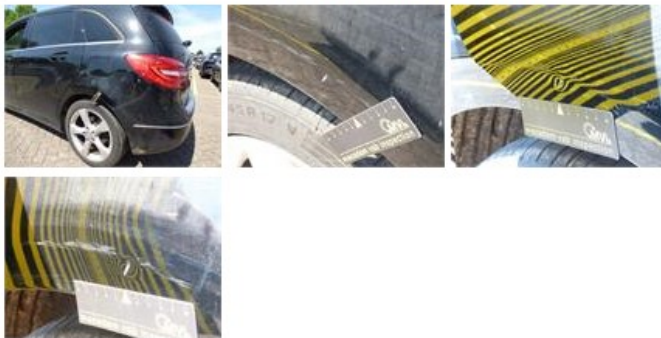
Wing R L, Bump(s) and scratch(es), LI - Repair and paint (complete) 332,20

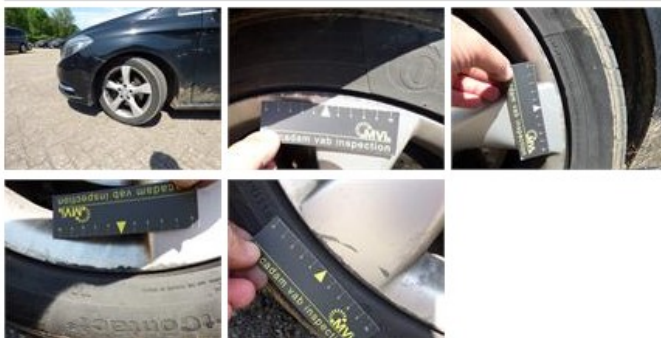
Alloy rim F L, Scratch(es), LI - Repair and paint (complete) 95,00

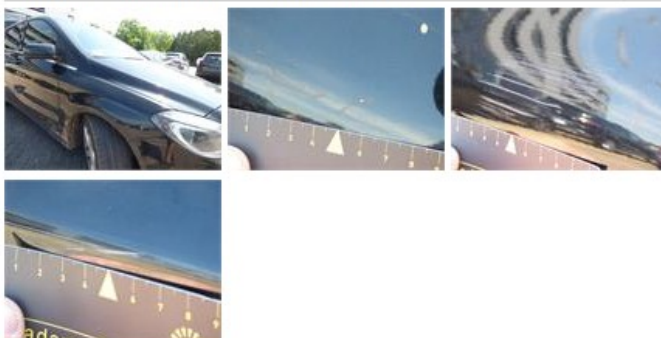
Wing F R, Scratch(es), LI - Repair and paint (complete) 220,18

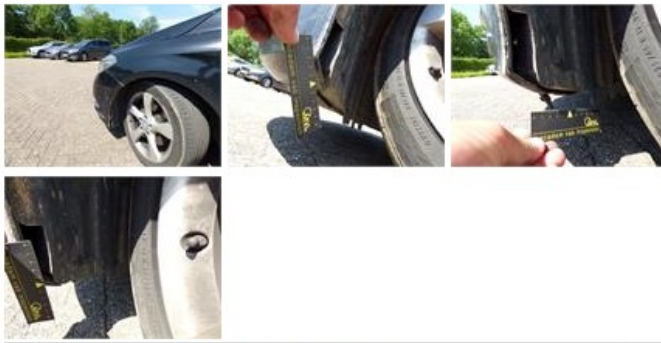
Wheel arch cover F R, Broken, E - Replace 102,21

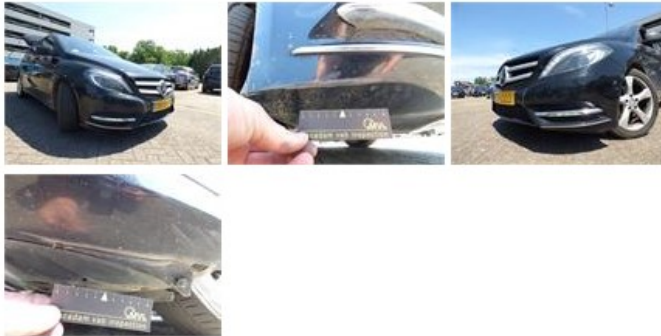
Front bumper, Scratch(es), LI - Repair and paint (complete) 211,80
