MERCEDES V KLASSE: 1HNT384

| Vinnumber: | WDF44781313006513 | Versionname: | |

Limited Technical Inspection

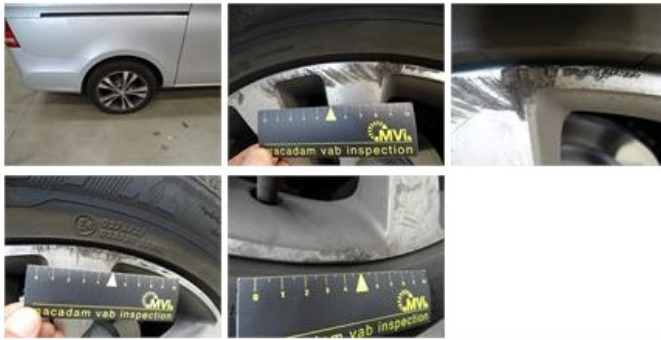
Alloy rim R R polished, Damaged, E - Replace 182,40

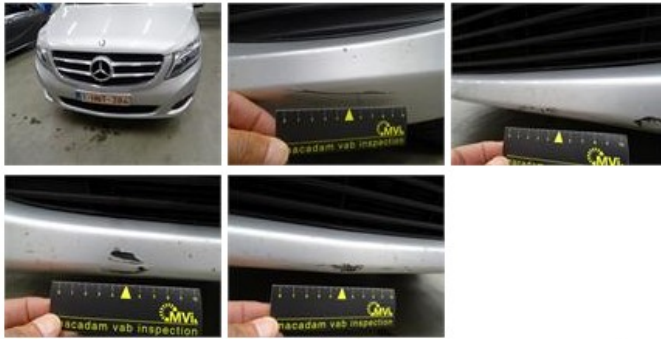
Front bumper, Scratch(es), LI - Repair and paint (complete) 158,85

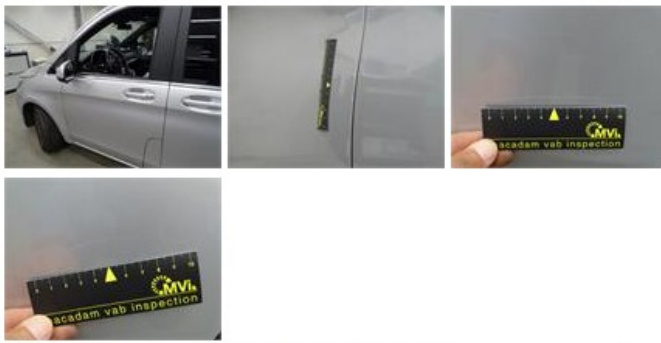
Door L L, Bump(s) and scratch(es), LI - Repair and paint (complete) 200,00

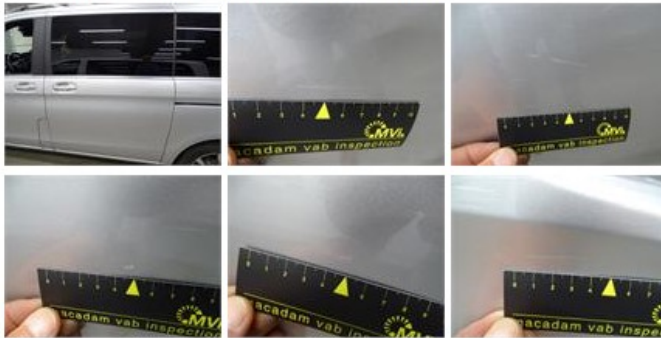
Door R L, Scratch(es), LI - Repair and paint (complete) 238,76

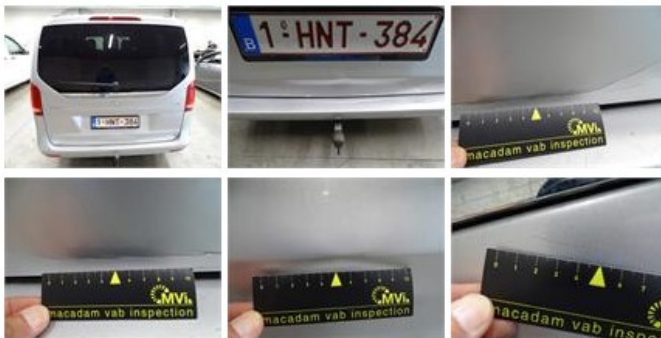
Tailgate, Bump(s) and scratch(es), LI - Repair and paint (complete) 506,02

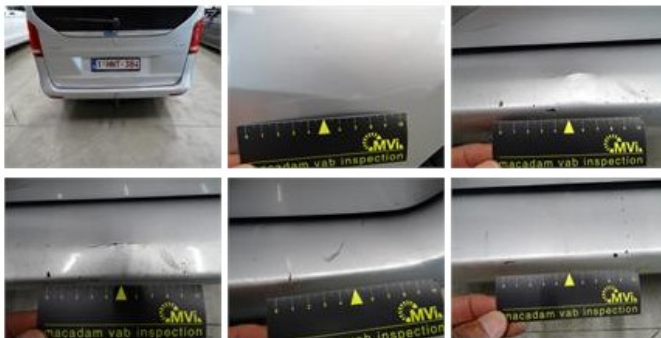
Bumper R, Damaged, LI - Repair and paint (complete) 158,85
