VOLKSWAGEN Golf: 1FDE038

Limited Technical Inspection

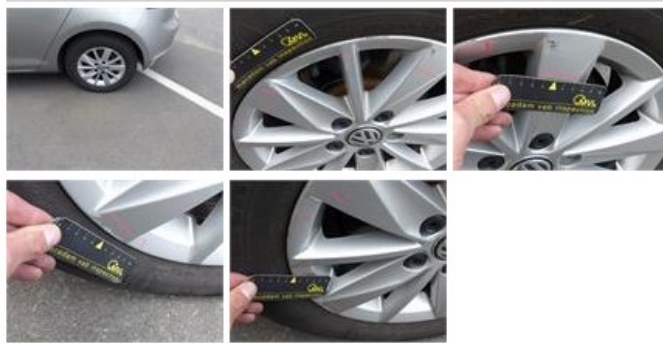
Alloy rim R L, Scratch(es), LI - Repair and paint (complete)	95,00
--	-------

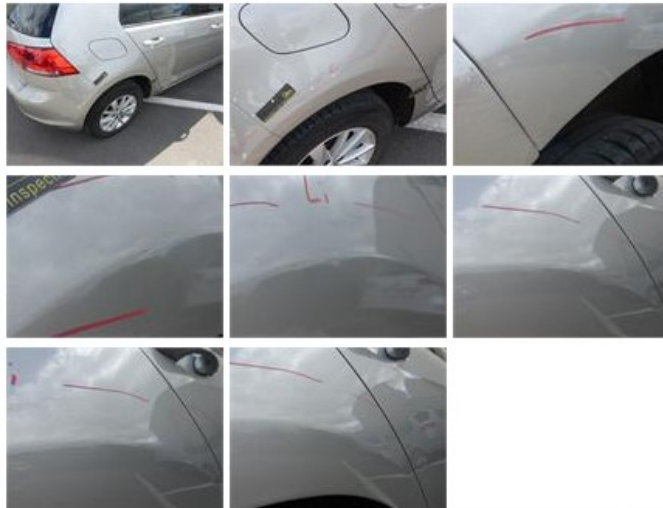
Wing R R, Scratch(es), LI - Repair and paint (complete) 356,20

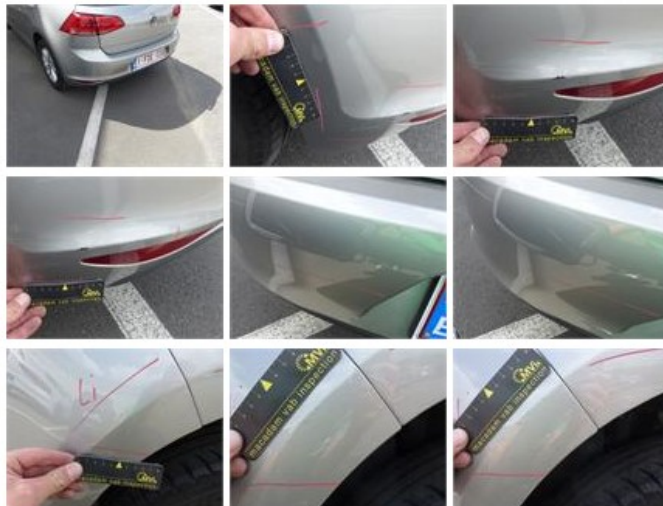
Bumper R, Damaged, LI - Repair and paint (complete) 259,80
