**VOLKSWAGEN Passat: 1EPS667**

**Limited Technical Inspection**

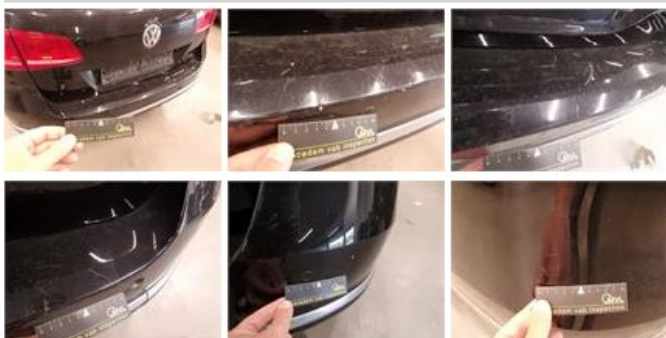
Repair kit	<b>Yes</b>
Total cost ex VAT	952,09
Bumper R, Bump(s) and scratch(es), LI - Repair and paint (complete)	211,80

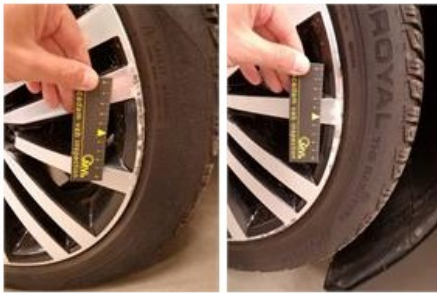
Alloy rim F R polished, Scratch(es), LI - Repair and paint (complete) 95,00
