SKODA Octavia: 1FNT866			
Vinnumber:	<b>TMBJG7NE4E0038061</b>	Versionname:	<b>OCTAVIA COMBI Ambition</b>
First Registrationdate:	<b>2/09/2013</b>	Fiscalpower:	<b>105PK</b>
Expertise Mileage:	<b>86759</b>	Power Kw:	<b>77</b>
Bodytype:	<b>Break</b>	Body color:	<b>Silver</b>
Gearbox:	<b>MAN 5 VIT</b>	Paint type:	<b>Metalic</b>
Transmission:	<b>Front</b>	Rims summer:	<b>Steel</b>
Fueltype:	<b>Diesel</b>	Oil level:	<b>OK</b>
Battery functioning:	<b>Yes</b>	Parking lot:	<b>4616</b>
Number of doors:	<b>5</b>		
Number of seats:	<b>5</b>		
Number head rests:	<b>5</b>		
Rims summer:	<b>Steel</b>		
Category:	<b>Passenger Car</b>		
Oil level:	<b>OK</b>		
Registration Certificate Car (BE):	<b>Yes</b>

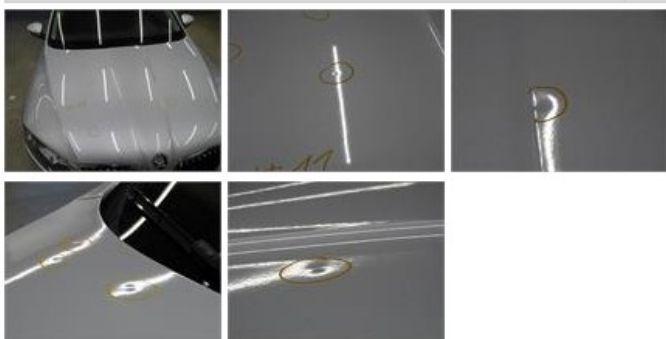
Assistance equipment			
Spare wheel	<b>Yes</b>	Jack	<b>Yes</b>
Total cost ex VAT			<b>2275,00</b>
Bonnet, Hail damage, PDR - Hail			<b>275,00</b>

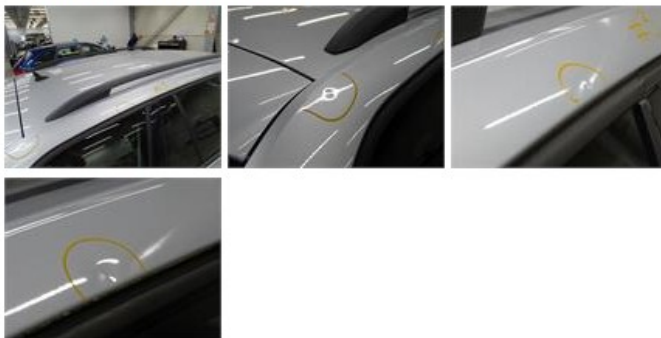
Roof pillar R, Hail damage, PDR - Hail 75,00

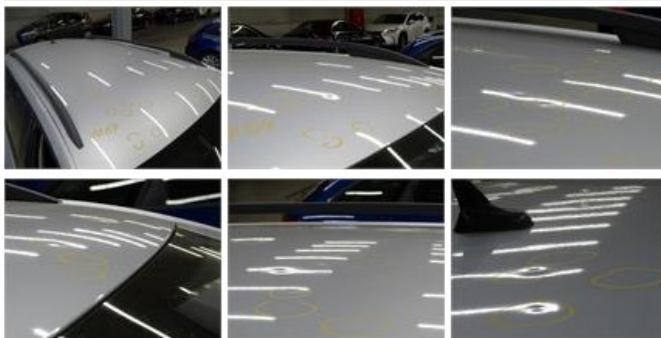
Roof, Hail damage, PDR - Hail 1600,00
