BMW X3: 1GBF961

Limited Technical Inspection

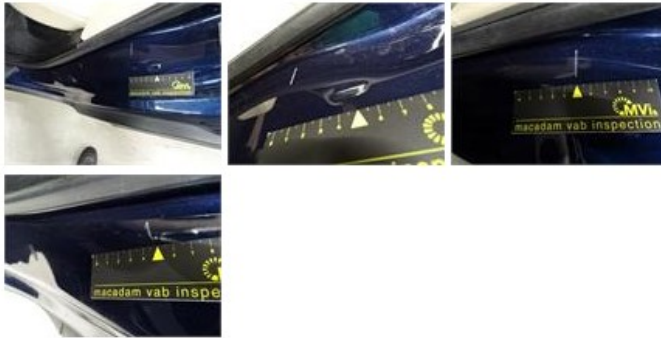
Rocker panel inner R L, Bump(s) and scratch(es), LI - Repair and paint (complete) 115,56

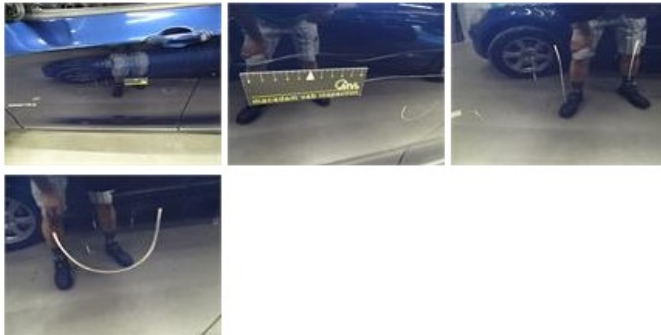
Door F L, Scratch(es), LI - Repair and paint (complete) 382,02
