BMW 3: 1FHY789

Limited Technical Inspection

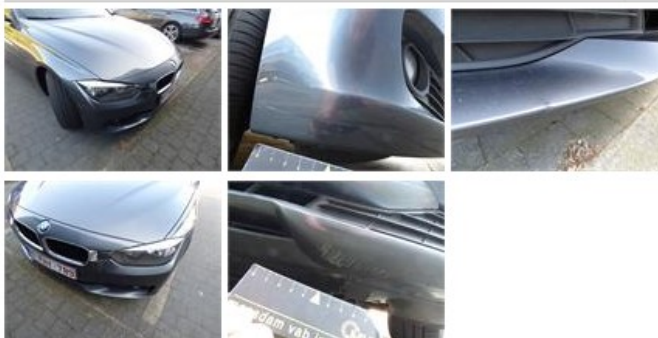
Front bumper, Scratch(es), LI - Repair and paint (complete) 211,80
