MINI Mini: 1ERL633			
Vinnnumber:	WMWSW71010T331650	Versionname:	MINI Cooper SD 136PK DPF
First Registrationdate:	1/03/2013	Fiscalpower:	
Expertise Mileage:	85874	Power Kw:	100
Bodytype:		Body color	Dark Grey
Gearbox:	MAN 6 VIT	Paint type	Metalic
Transmission:		Rims summer	Aluminium
Fueltype:	Diesel	Oil level	OK
Battery functioning	Yes	Parking lot	4314
Number of doors	3		
Number of seats	4		
Number head rests	4		
Rims summer	Aluminium		
Category	Passenger Car		
Oil level	OK

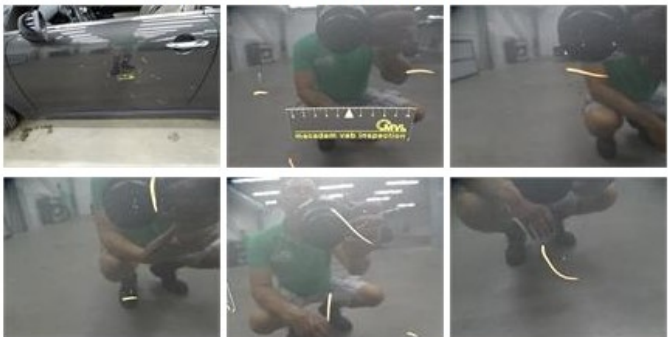
Assistance equipment			
Repair kit	Yes	Compressor	Yes
Total cost ex VAT			2108,05
Wing R R, Scratch(es), Acceptable			0,00
<i>No pictures to display</i>			
Door F L, Scratch(es), LI - Repair and paint (complete)			318,35

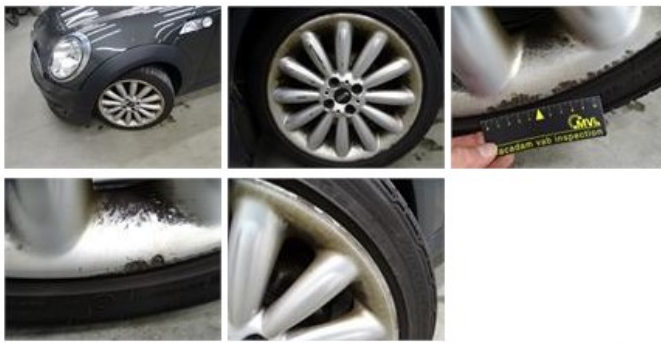
Alloy rim F L, Damaged, E - Replace 235,20

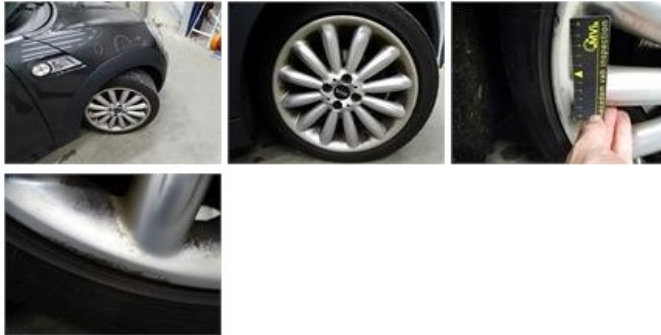
Alloy rim F R, Scratch(es), LI - Repair and paint (complete) 95,00

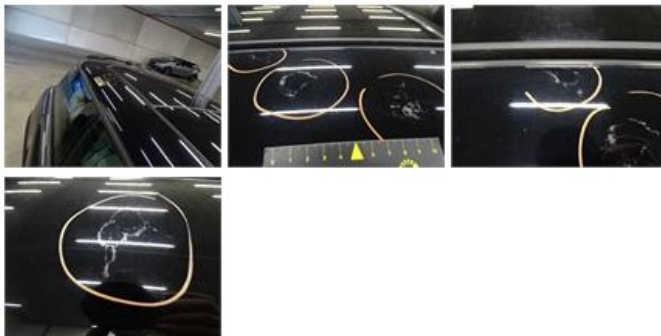
Roof, Chemical polution, LI - Repair and paint (complete) 481,50

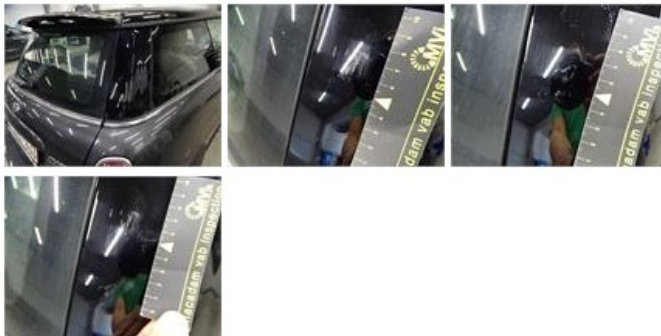
Wing R R, Chemical polution, LI - Repair and paint (complete) 100,00
