OPEL Astra: 1GHX525

Limited Technical Inspection

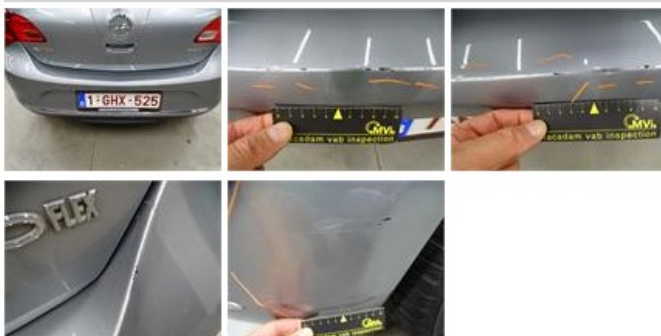
Bumper R, Scratch(es), LI - Repair and paint (complete)	211,80
---	--------
