VOLKSWAGEN Amarok: 1EZG364

Limited Technical Inspection

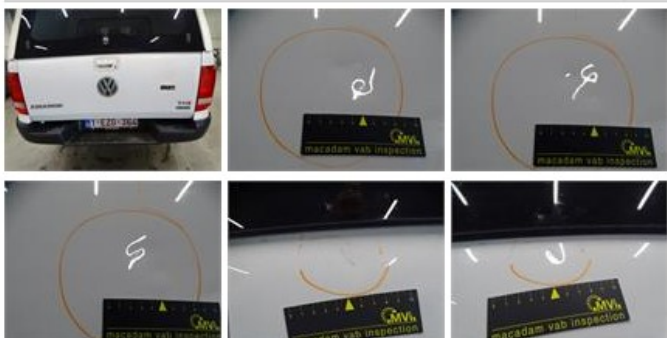
Tailgate, Bump(s) and scratch(es), LI - Repair and paint (complete)	362,02
---	---------------

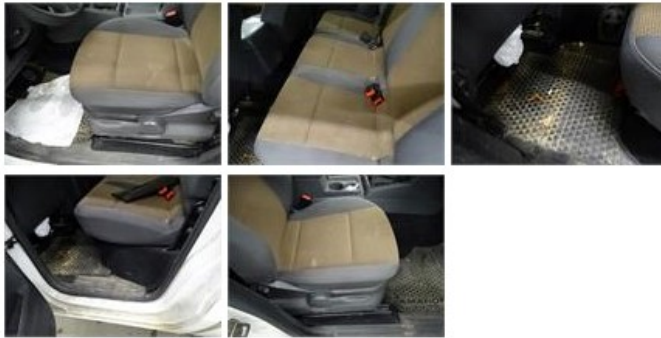
Interior, Dirty, Cleaning 0,00

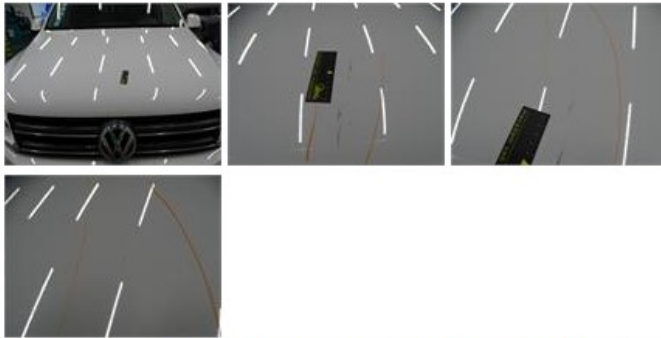
Bonnet, Scratch(es), LI - Repair and paint (complete) 348,09
