TOYOTA AURIS: 1LHJ981

Limited Technical Inspection

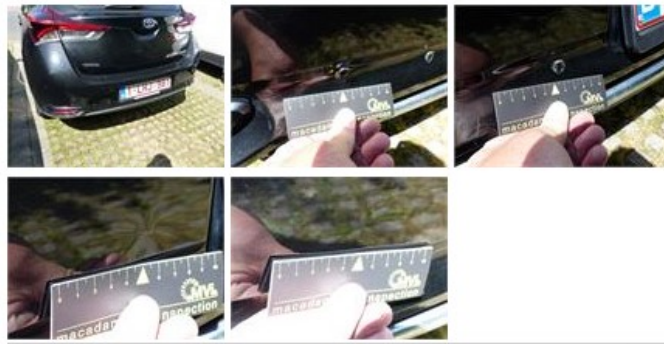
Bumper R, Bump(s), LI - Repair and paint (complete) 283,80

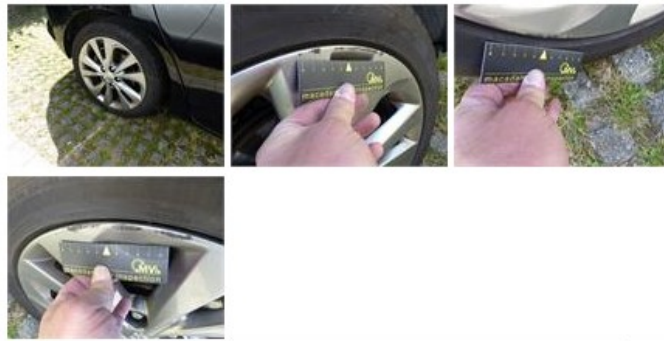
Alloy rim R R, Scratch(es), LI - Repair and paint (complete) 95,00

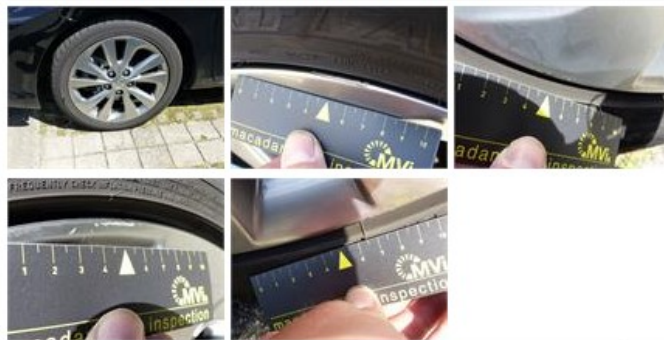
Alloy rim F L, Scratch(es), LI - Repair and paint (complete) 95,00

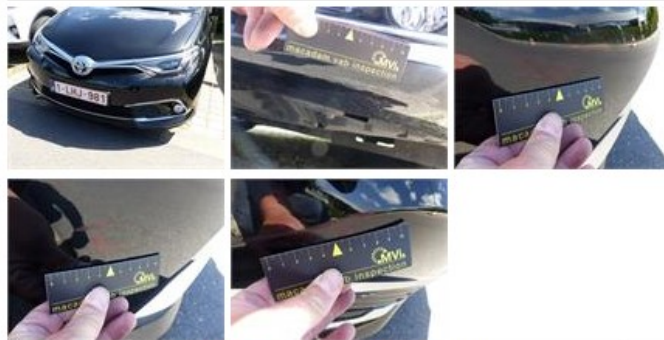
Front bumper, Scratch(es), LI - Repair and paint (complete) 211,80

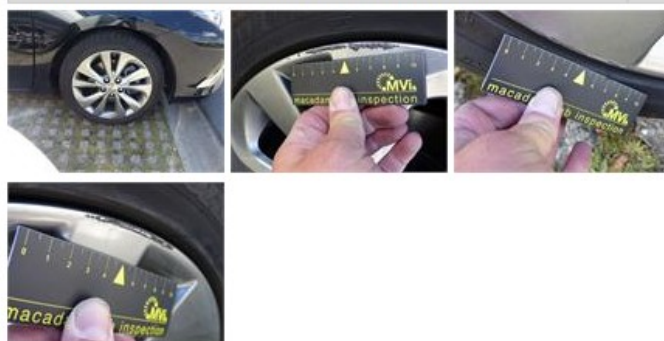
Alloy rim F R, Scratch(es), LI - Repair and paint (complete) 95,00
